APPENDIX D

Drawings and Inspection Reports of Bridges in Area

Armstrong Dam Removal Feasibility Study

BRIDGE NO. B-21-041

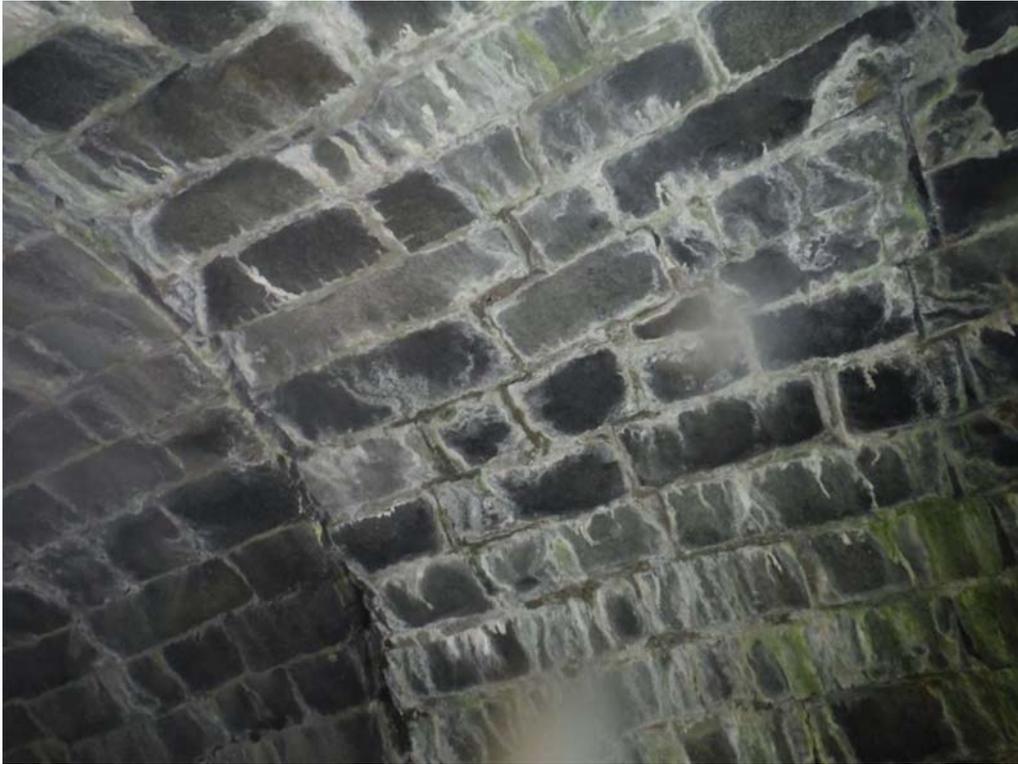
(Fair); The arch exhibits moderate to heavy efflorescence and missing mortar throughout the underside with the heaviest efflorescence occurring at the 15'-0" section east of the construction joint. **(See photos 8, 13, & 14)** The construction joint between the two portions of the arch is between 3"-4" wide. Several isolated stones were found to be cracked throughout the structure. A 1/8" crack is present on the North section of the arch. The crack is approximately 10ft from the west fascade and extends from the springline to the crown. **(See photo 15)** The crack does not appear to have changed since the last inspection report. The eastern fascade stones are pulling away from the arch. The gap between stones is as large as 2.5" and extends from the south springline to the north springline. **(See photo 16 & 17)** The previous inspection report describes this separation as 1.5" wide.

(Fair); Poor drainage and excessive water seepage has caused the masonry joints in the structure to become loose or missing with moderate to heavy efflorescence throughout. The west spandrel wall is in satisfactory condition with only minor areas of loose or missing mortar **(See photos 13 & 14)**

Photo 13: Heavy efflorescence and missing mortar on east underside of arch

- **Item 59.1 - Arch/Arch Ring**; Realign and secure eastern fascia stones to superstructure.
- **Item 59.10 - Masonry Joints**; Clean and re-point deficient masonry joints.
- **Item 60.1.g - Pointing**; Clean and re-point deficient masonry joints .
- **Item 59.5 - Spandrel walls**; Replace missing stone in east spandrel wall.

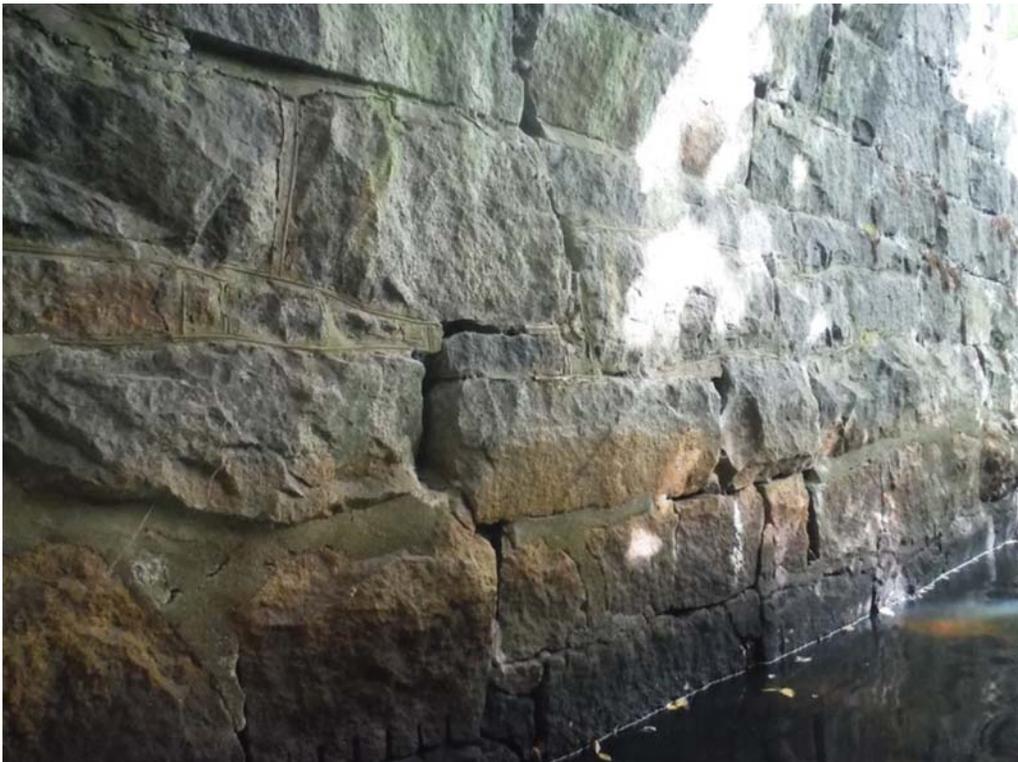
Photo 14: Typical missing mortar throughout underside of structure

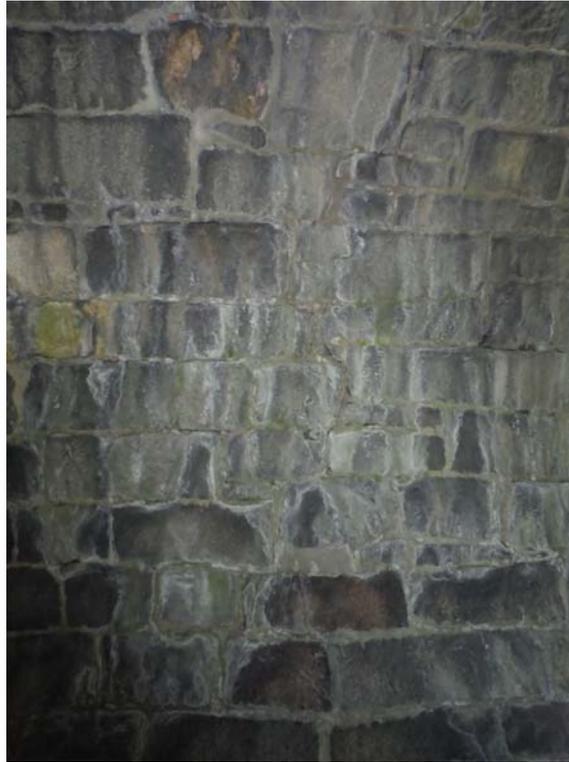
Photo 15: Crack in north section of arch from springline to crown

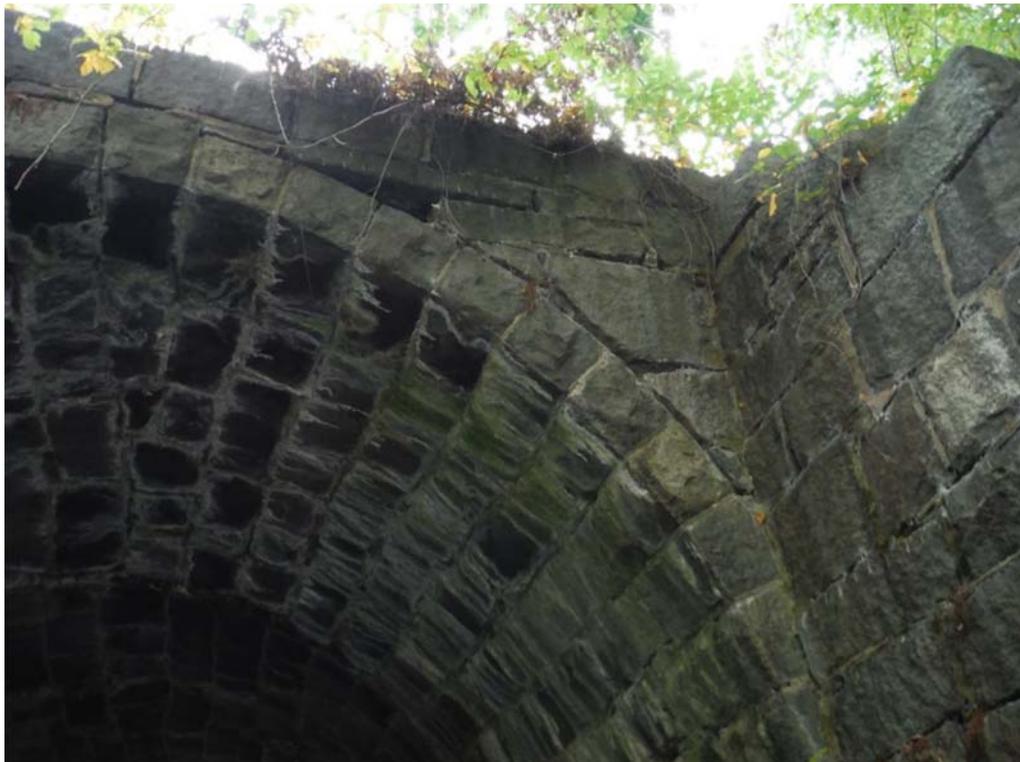
(Fair); The east spandrel wall has missing mortar and minor vegetation growth throughout. A stone is missing from the north end of the east fascia. **(See photo 18)** The west spandrel wall is in satisfactory condition with a single marking of graffiti above the keystone. The condition of both walls appear unchanged since the previous inspection report.

Photo 18: East spandrel wall missing stone and missing mortar

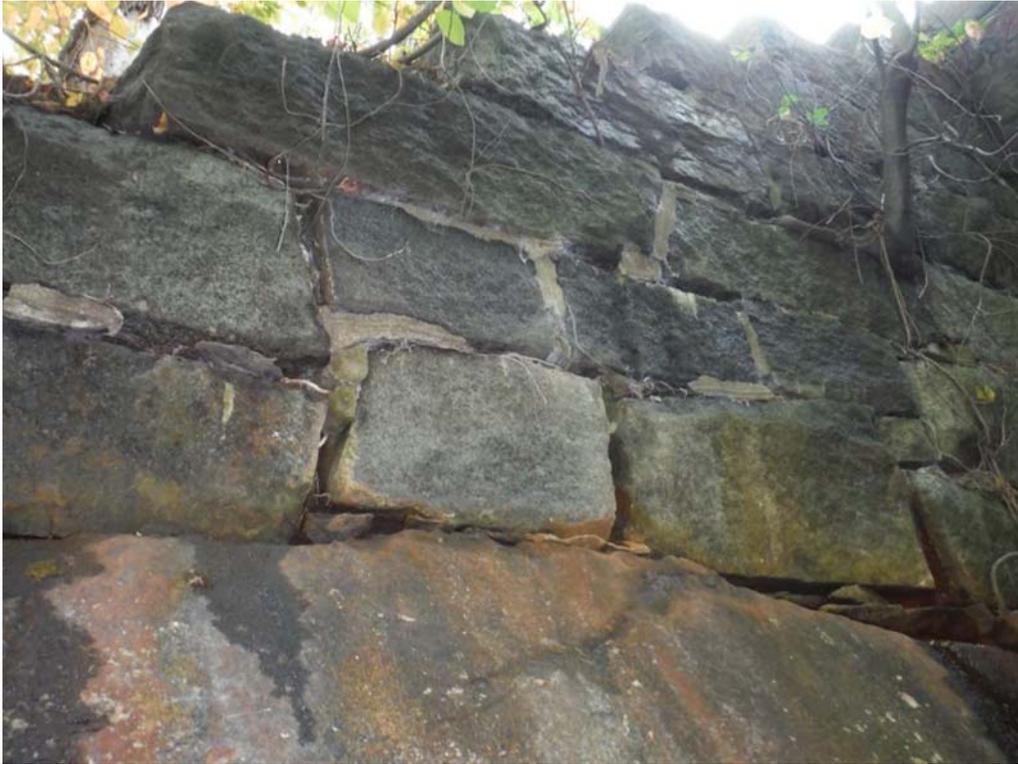
(Fair); Areas of missing mortar is common in all wingwalls and retaining walls. The most severe repairs needed are at the southeast wingwall where almost all the mortar joints are loose or missing. **(See photo 21)**

Photo 21: Missing mortar and heavy vegetation growth at southeast wingwall

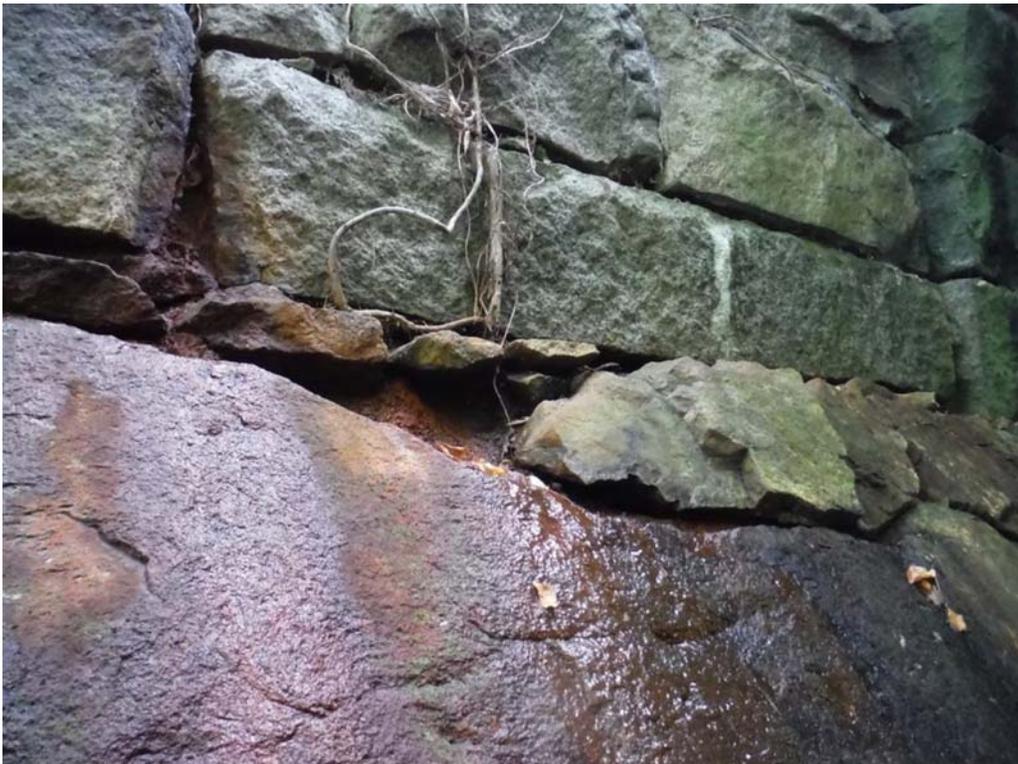
Photo 22: Cracked and missing stone directly below southeast wingwall

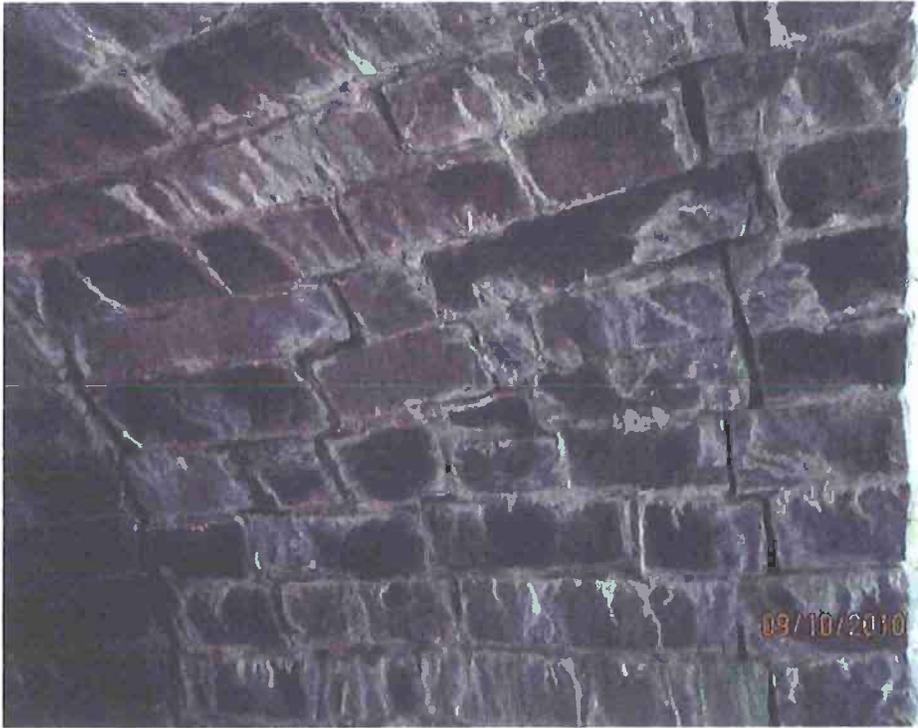
Photo #11 – Condition of North side of East portion of Arch. Note Separation of East Fascia Stones

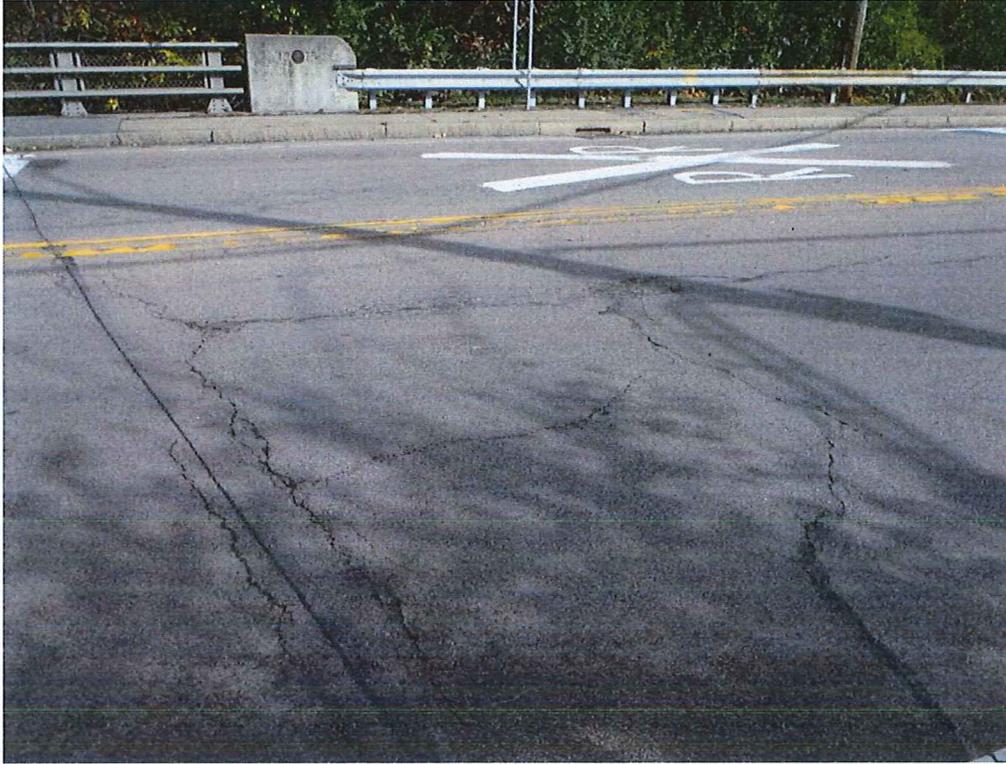
Photo 1: Transverse cracking in the wearing surface by the east abutment and map cracking in the east approach, eastbound roadway.

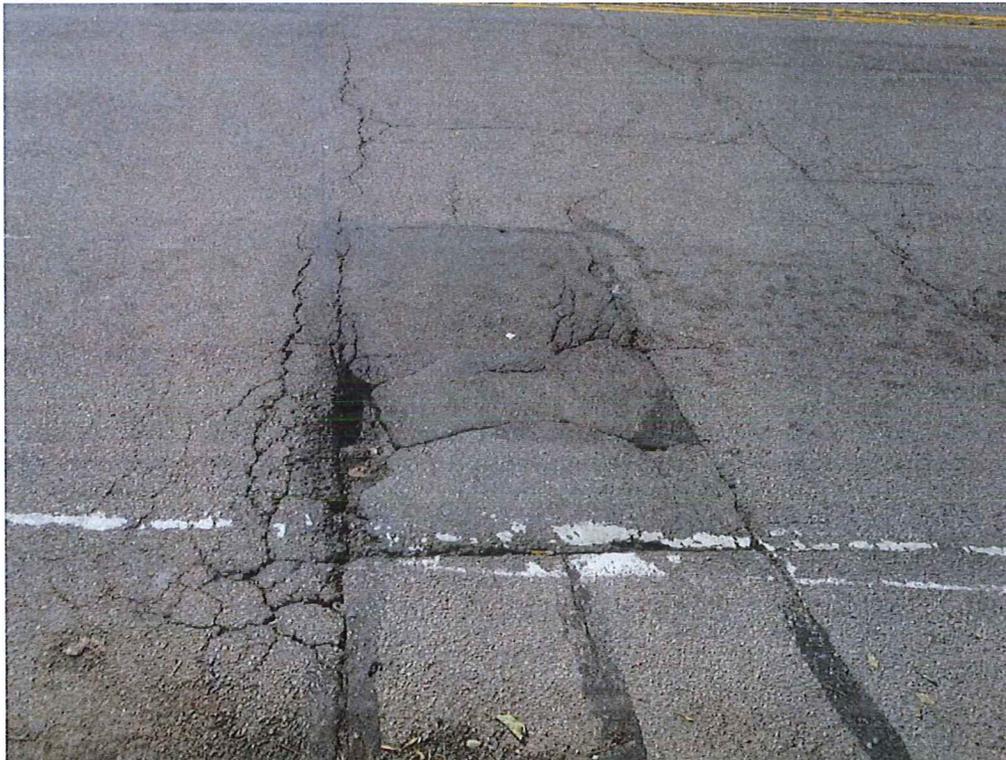
Photo 2: West approach north end of west abutment by fog line, 3' x 3' bituminous patch with 2' x 8' x 4" pothole and cracking.

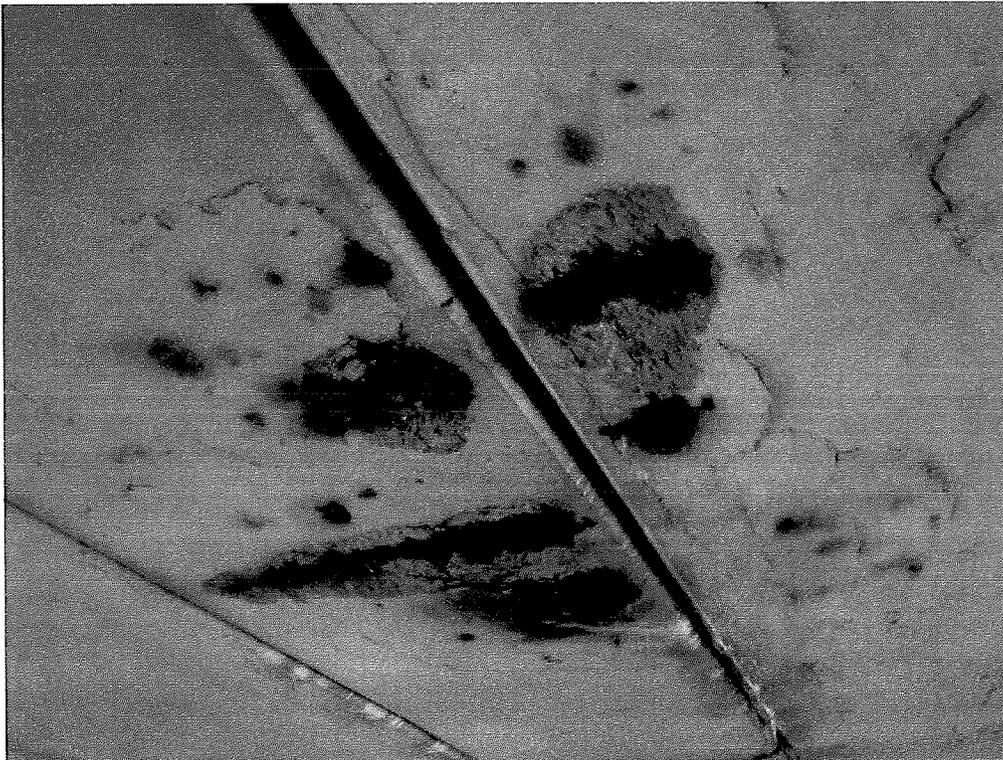
Photo 4: Beams 7 and 8, westerly end to midspan, numerous delaminated areas with spalling and rust staining.

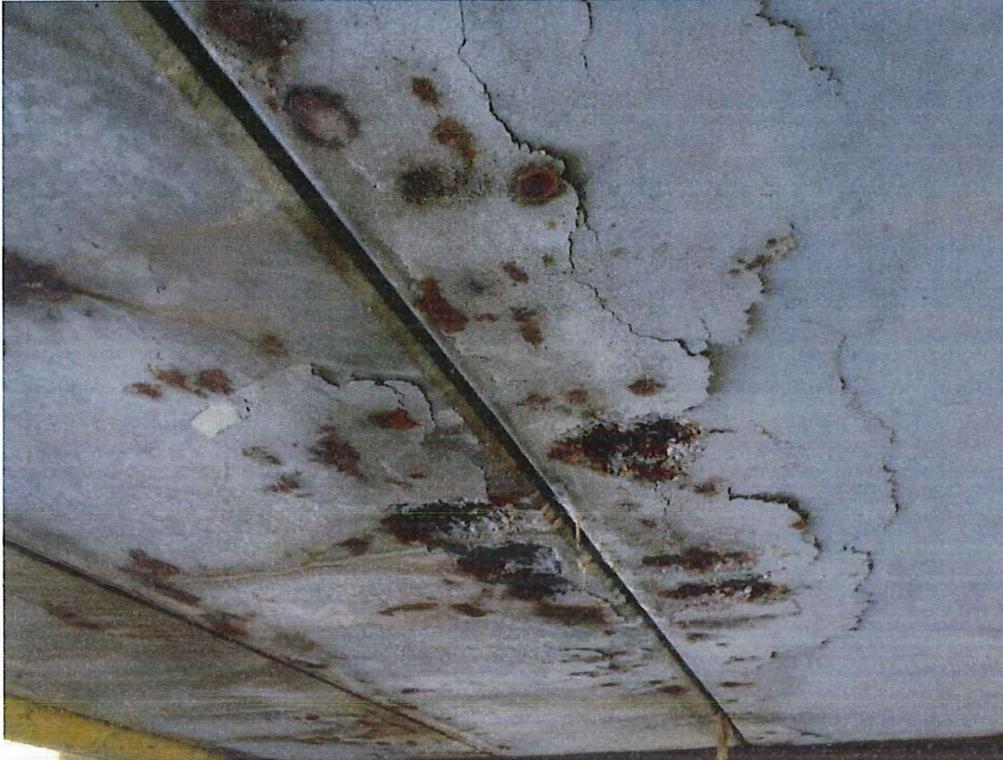
Photo 5: Between beams 10 and 11, looking west, both beams have minor spalls with rebar exposed, delamination and rust staining.

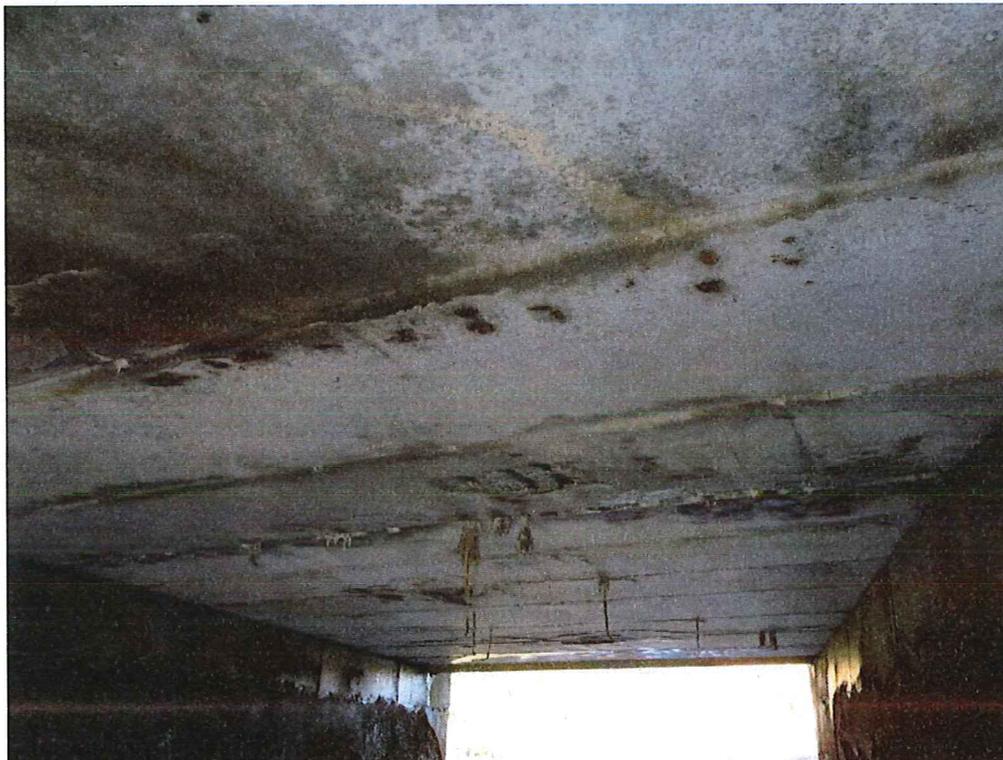
Photo 6: Looking north, typical underside with oakum hanging down between beams 1&2, 5&6, 7&8, 9&10 and 10&11.

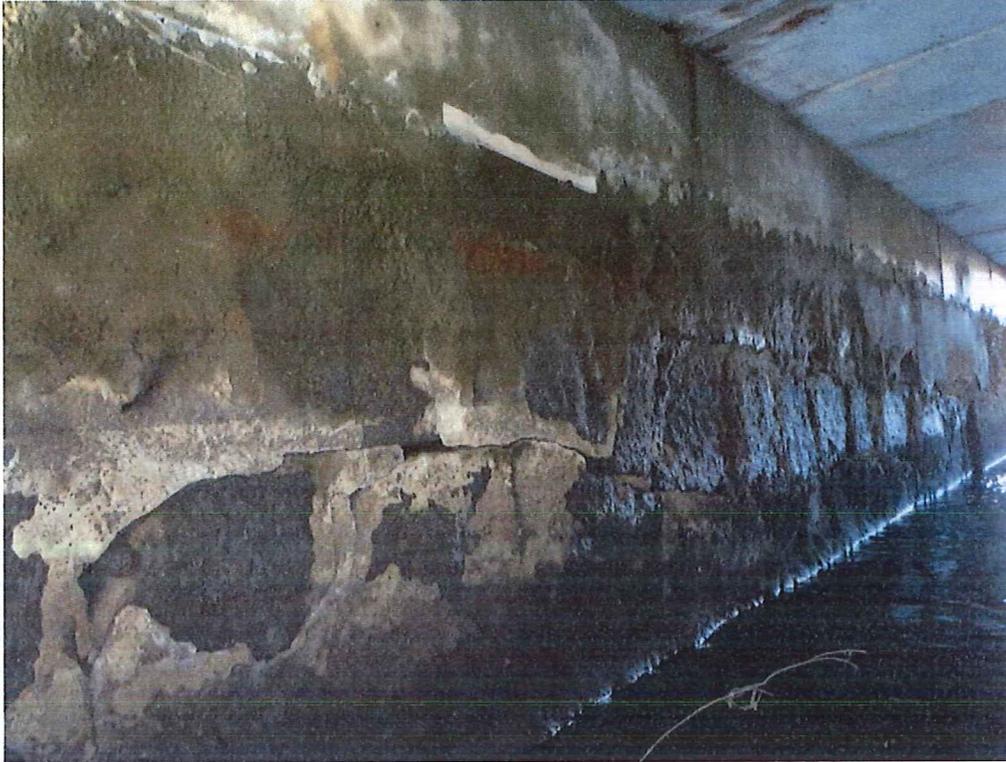
Photo 7: West breastwall between beams 3 and 10, horizontal crack between granite blocks and concrete breastwall and deteriorating gunite.

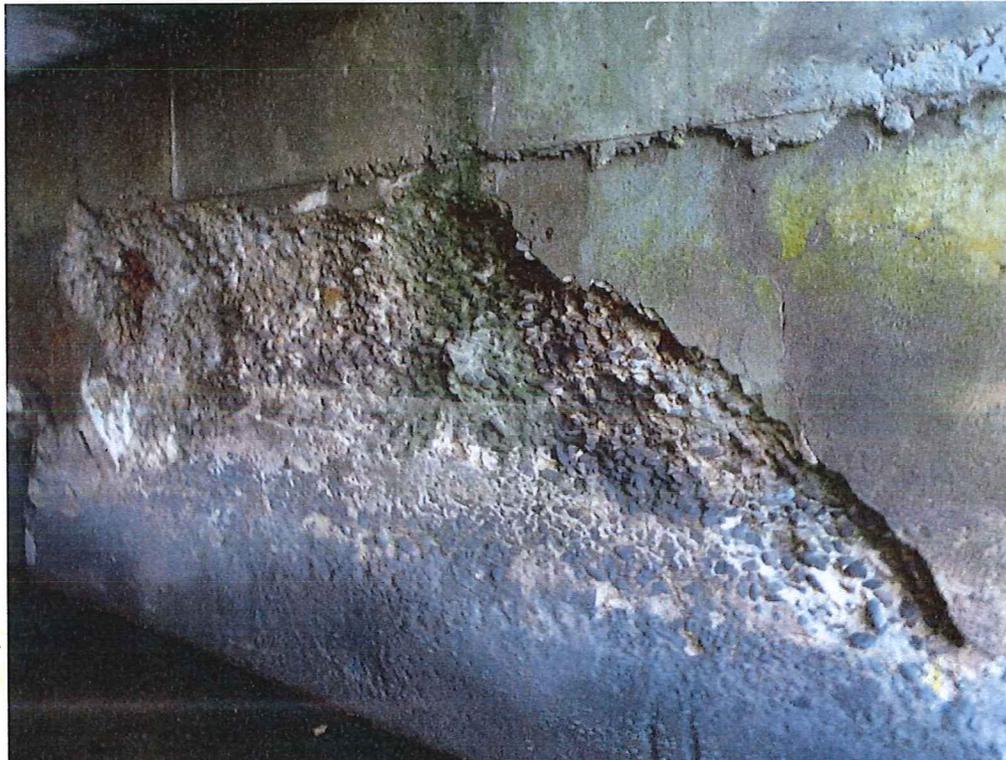
Photo 8: West breastwall north end, heavy spalling/ abrasion, 10' L x 38" H x up to 5" D.

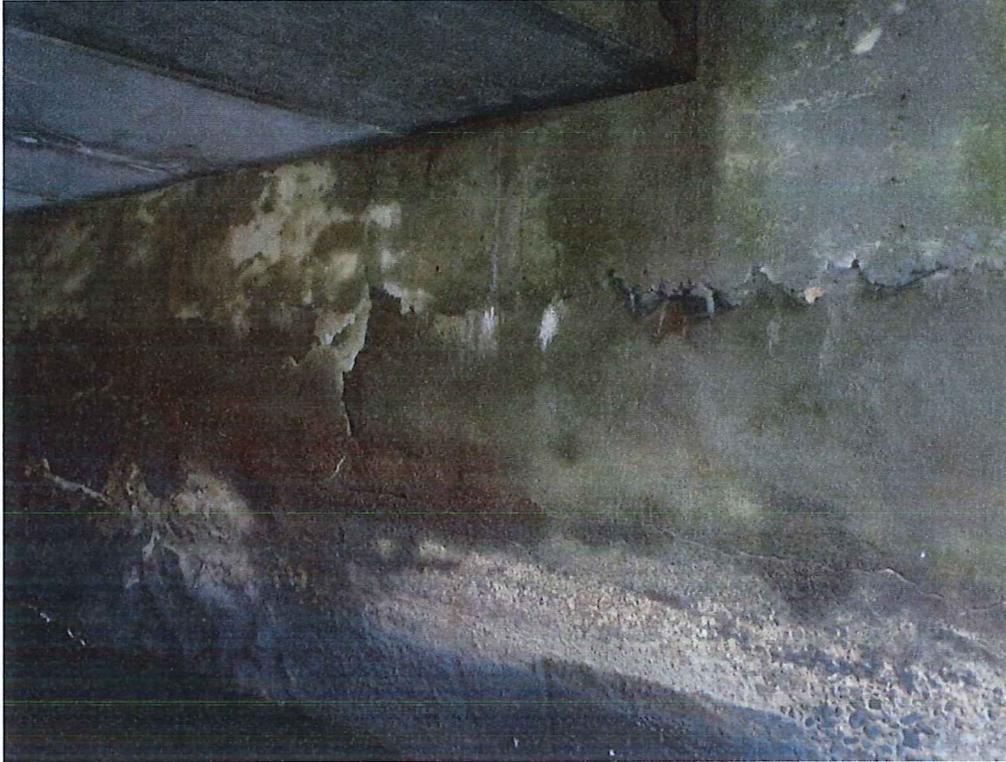
Photo 9: East breastwall between beams 1 and 2 adjacent to cap, moderate spall with rebar exposed and delamination as well as deteriorating gunite in breastwall.

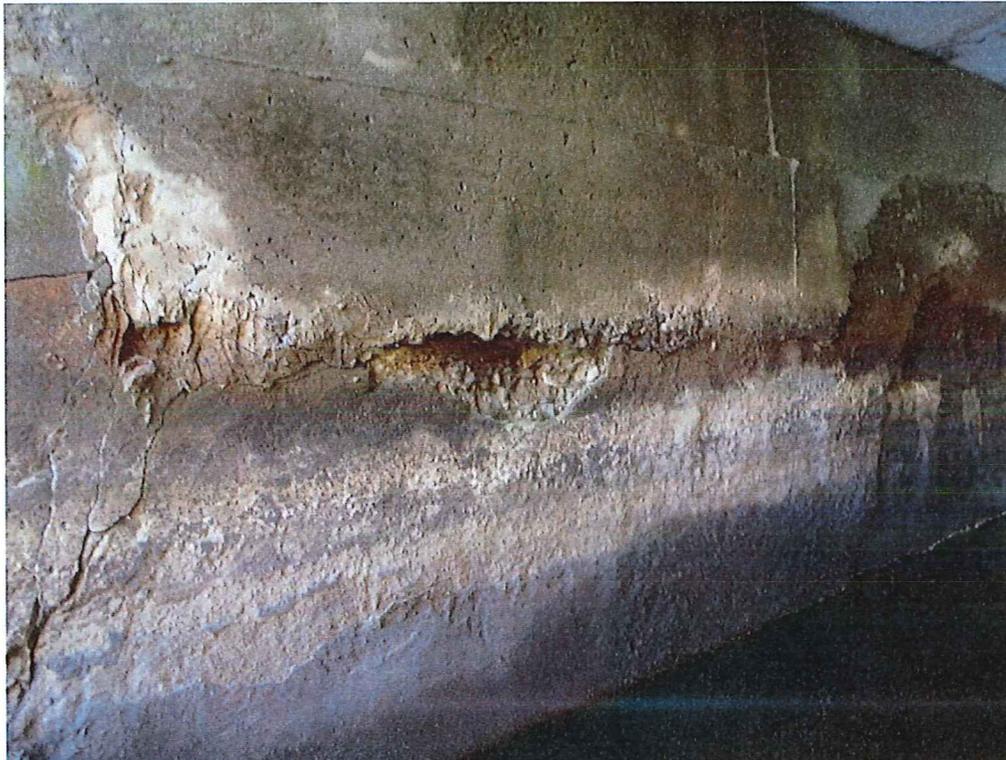
Photo 10: East breastwall, north end has spalling/ abrasion, 29" W x 10" H x up to 4" D below the concrete cap, with cracking at northeast corner of breastwall.

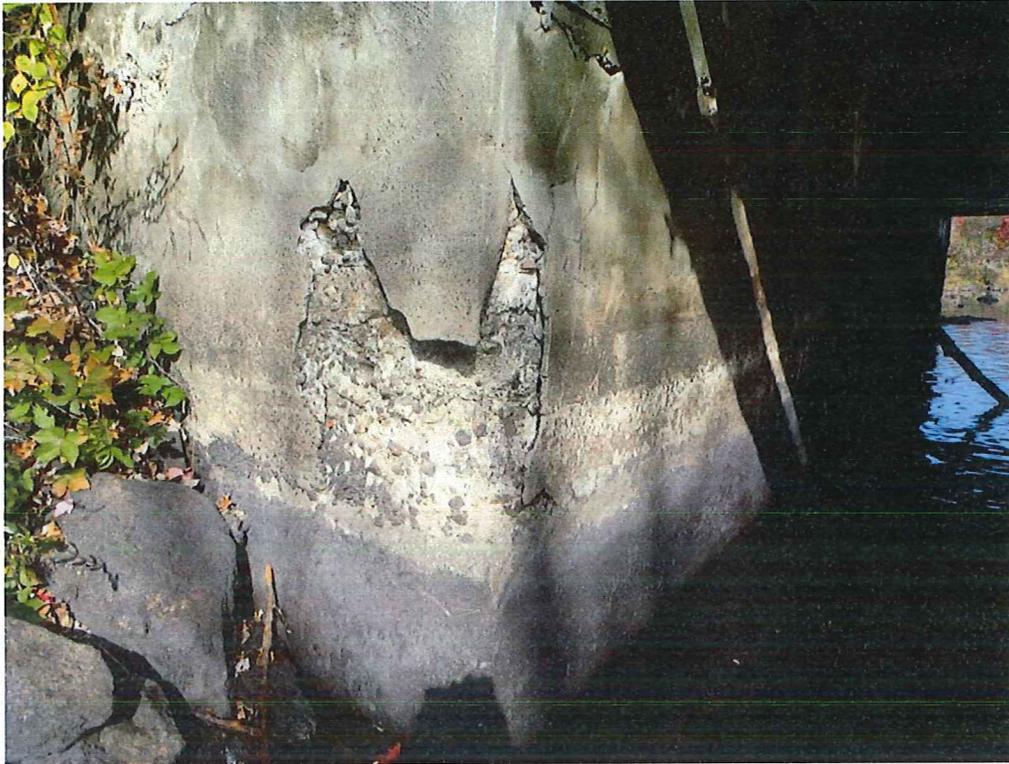
Photo 11: Southwest wing, moderate corner spall, 2' 8" W x 2' H x up to 3" D with delamination and a surface spall west of corner spall.

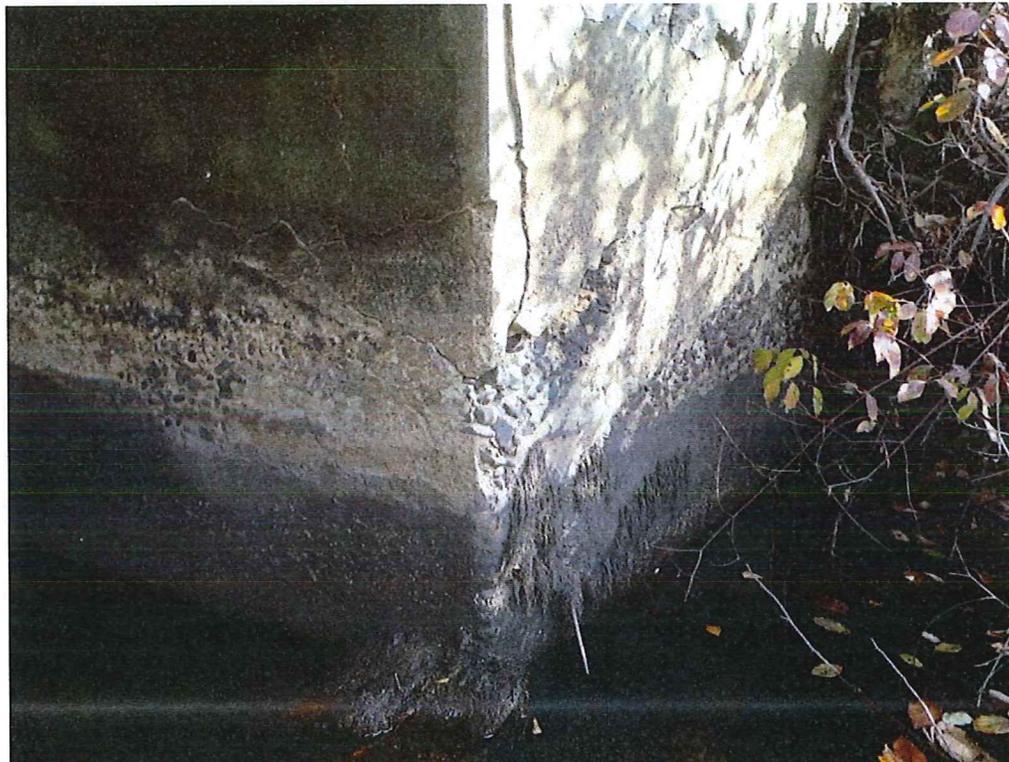
Photo 12: Southeast wing, minor spall with delamination and cracking.

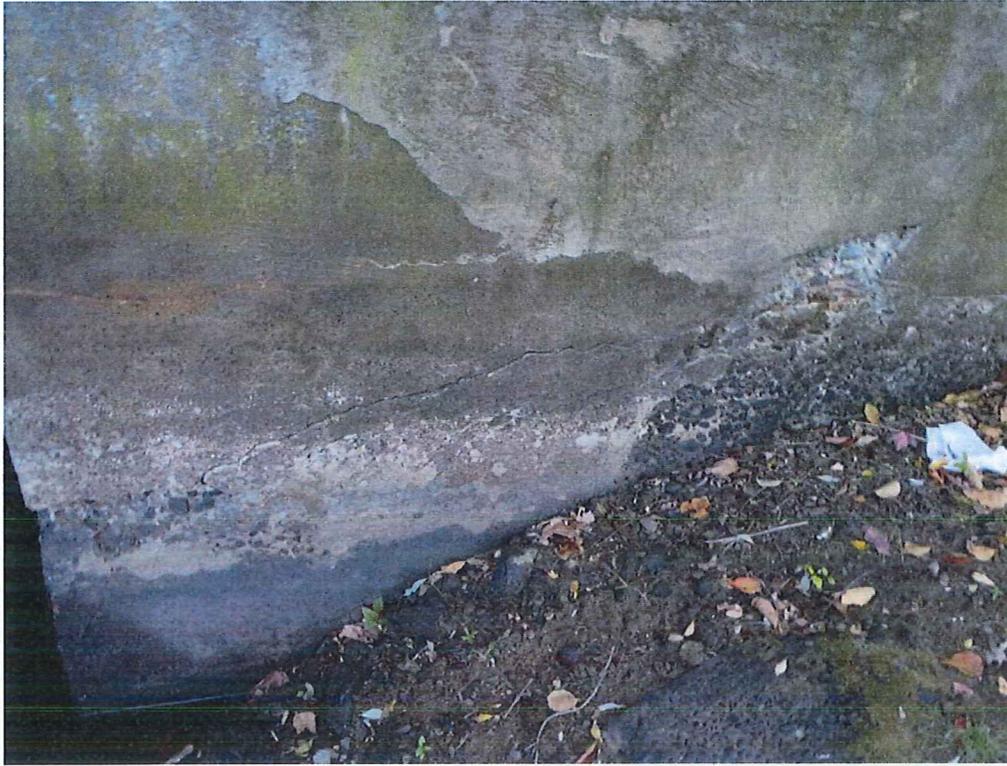
Photo 13: Northwest wing, two minor spalls with delamination and cracking.

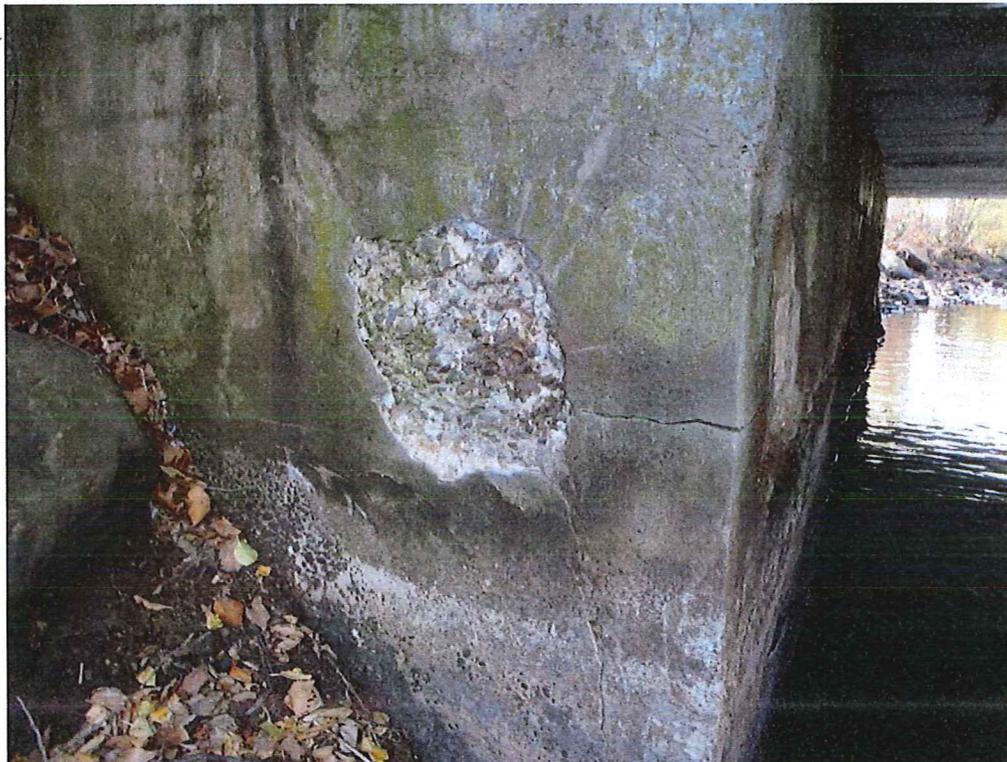
Photo 14: Northeast Wing, minor spall with delamination and cracking.
Spall measures 19" W x 18" H x up to 2-1/4" D.

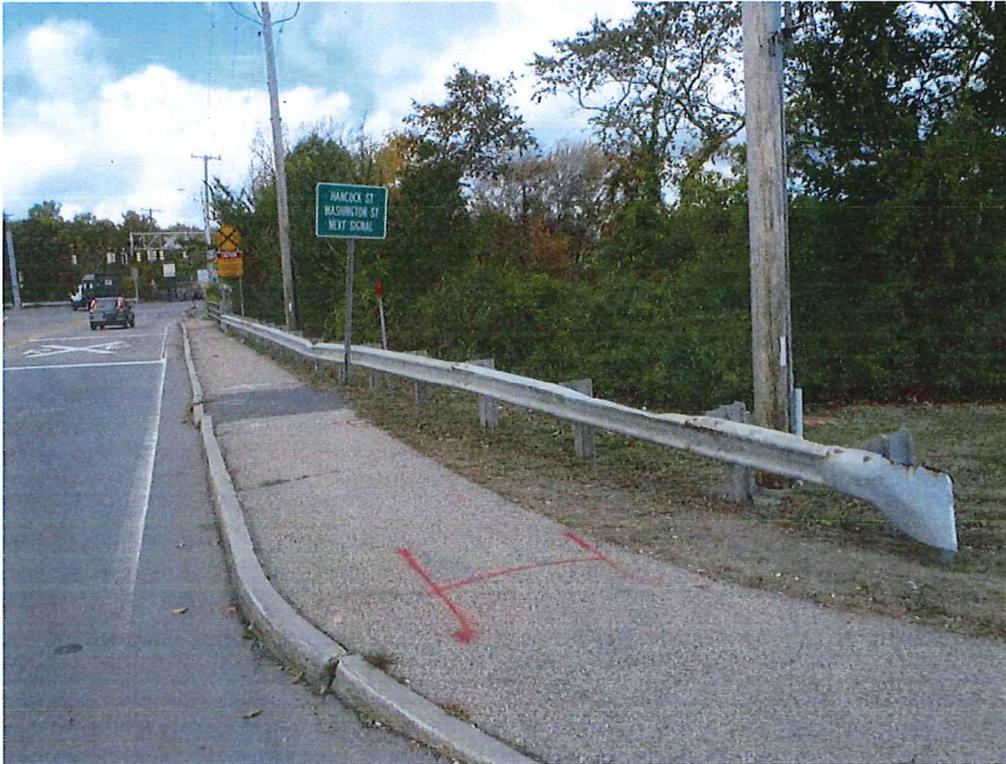
Photo 15: Two areas of collision damage in the northeast approach railing.

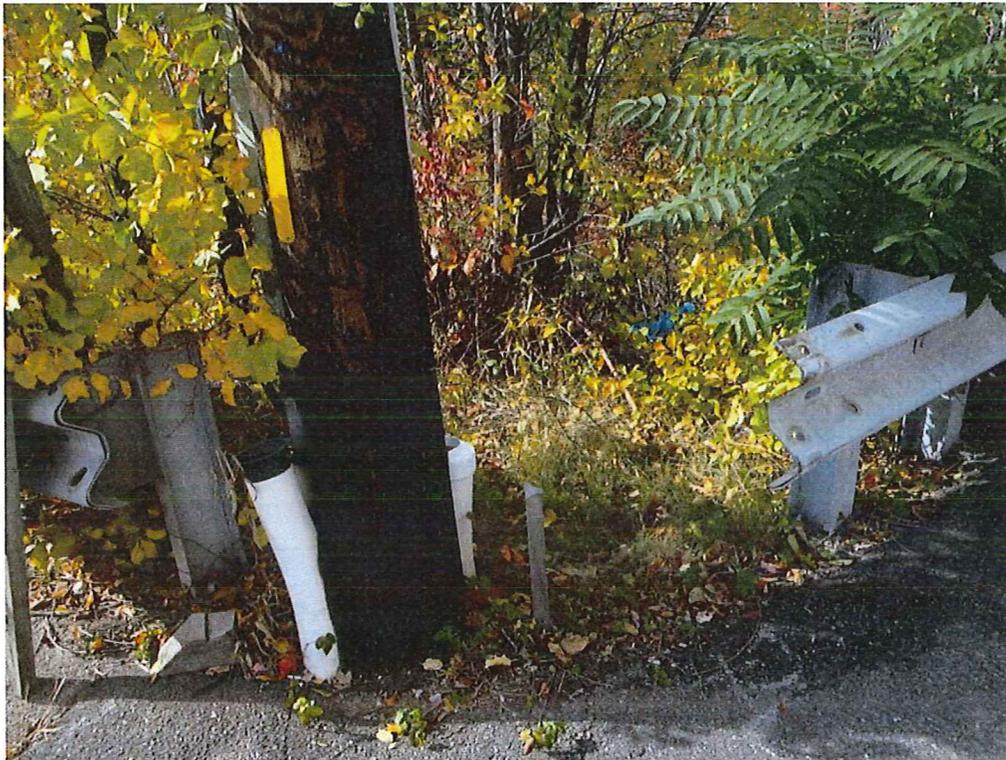
Photo 16: Southeast corner, five foot section of guardrail missing. Leveling patch at southeast approach sidewalk.

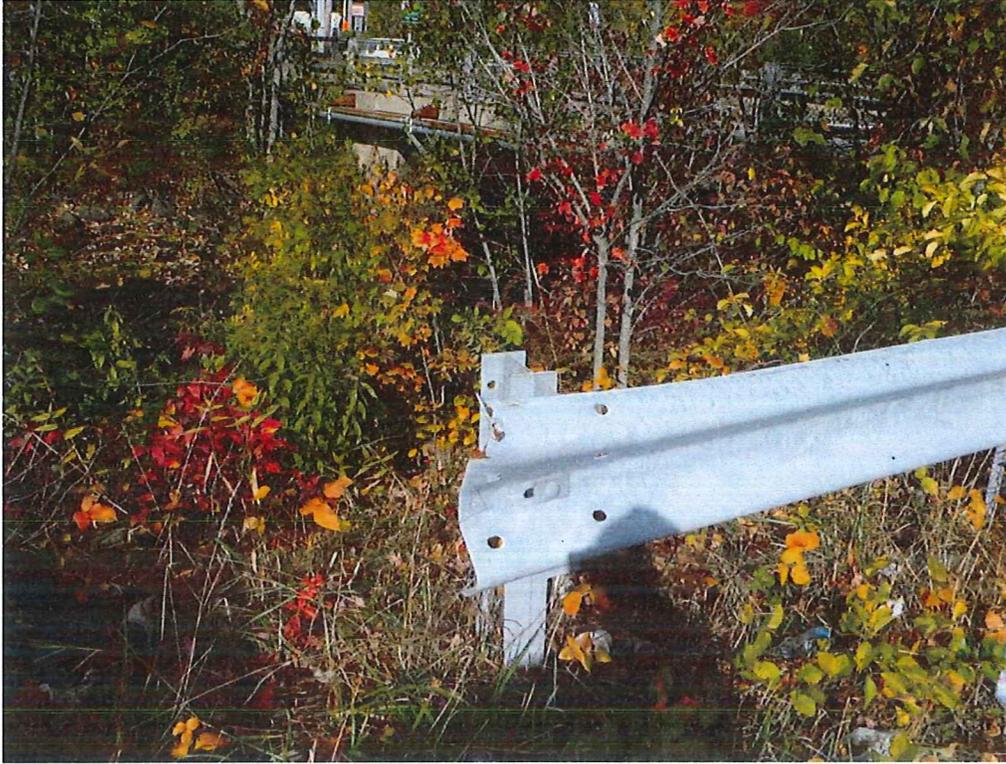
Photo 17: Southeast approach rail missing boxing glove end.

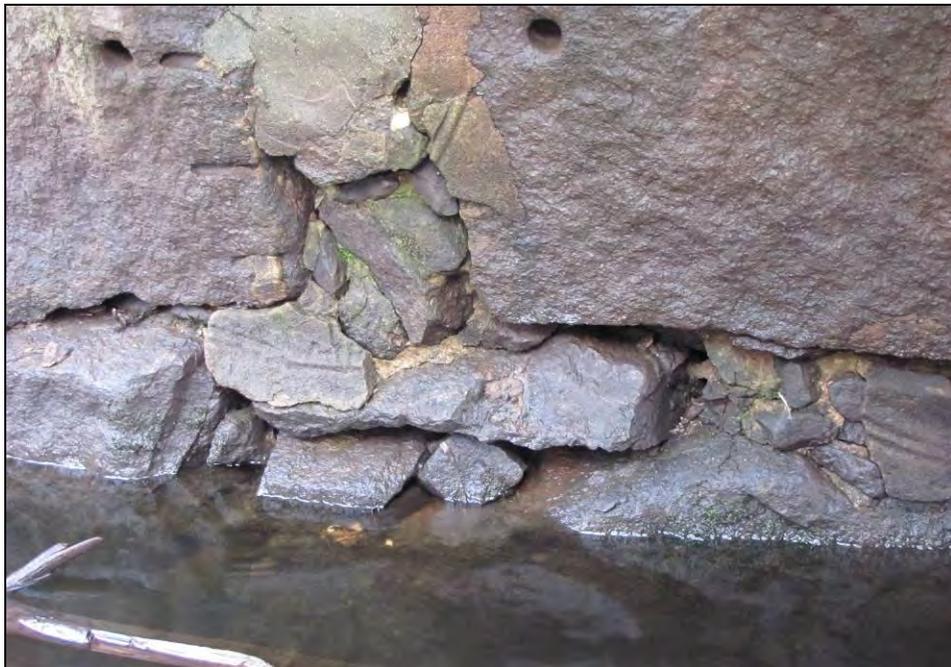
Photo No. 18 – Cracked, loose and missing mortar between granite blocks at abutment stem (typ.)

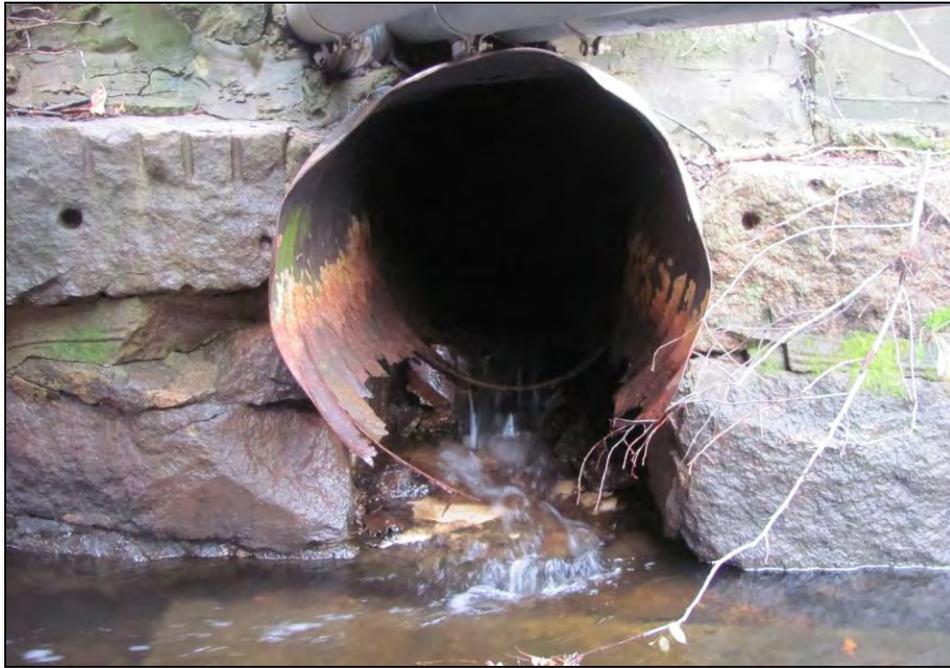
Photo No. 19 – South Abutment with drain pipe with 100% loss

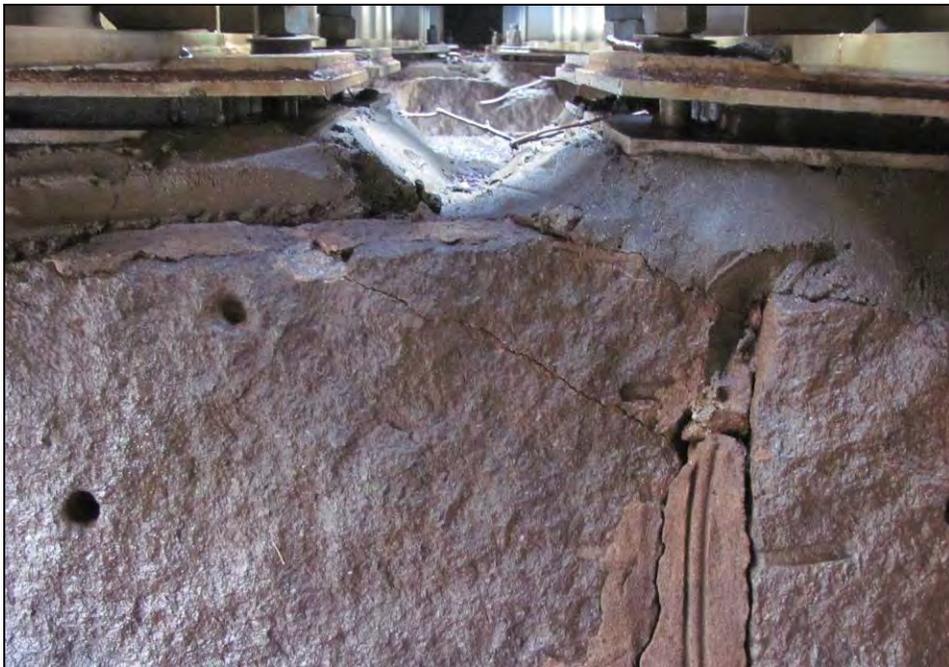
Photo No. 22 – 10” long diagonal crack in top granite block at Pier 2 between Beams B and C

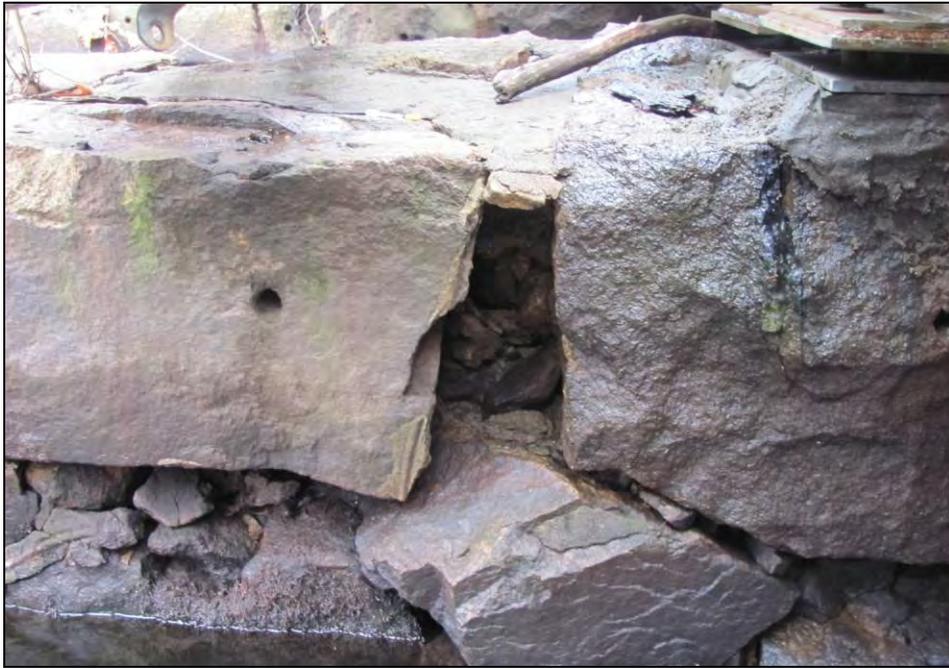
Photo No. 23 – West end of Pier 2, south face with 14" high by up to 8" wide by 14" deep void

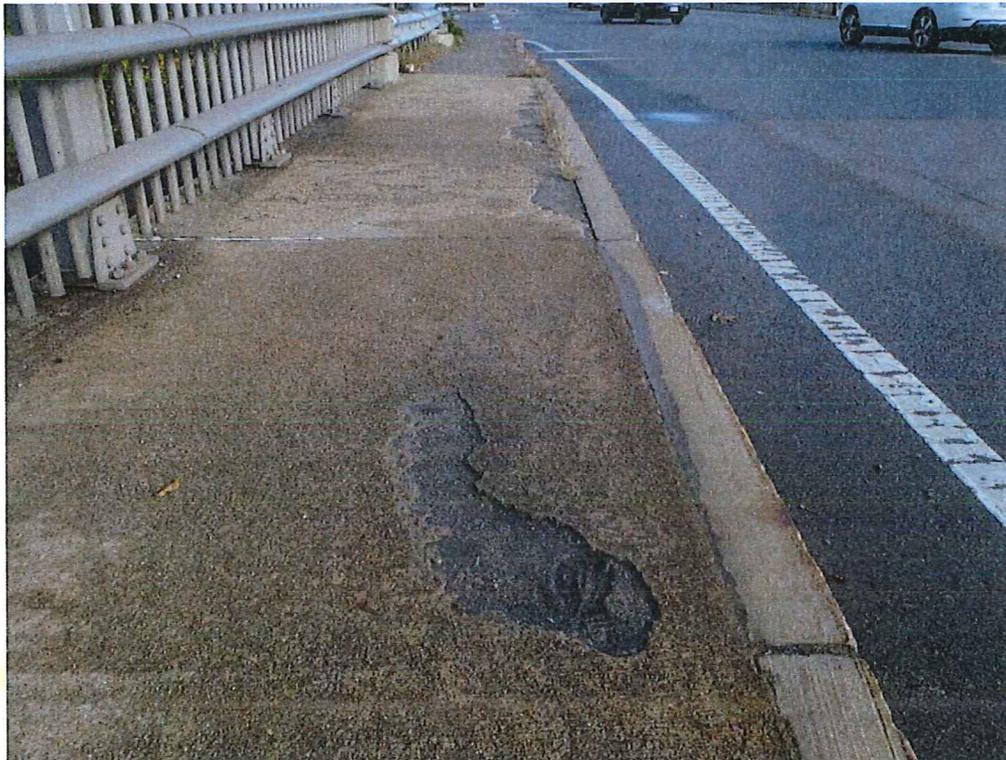
Photo 4: Numerous spalls at west sidewalk.

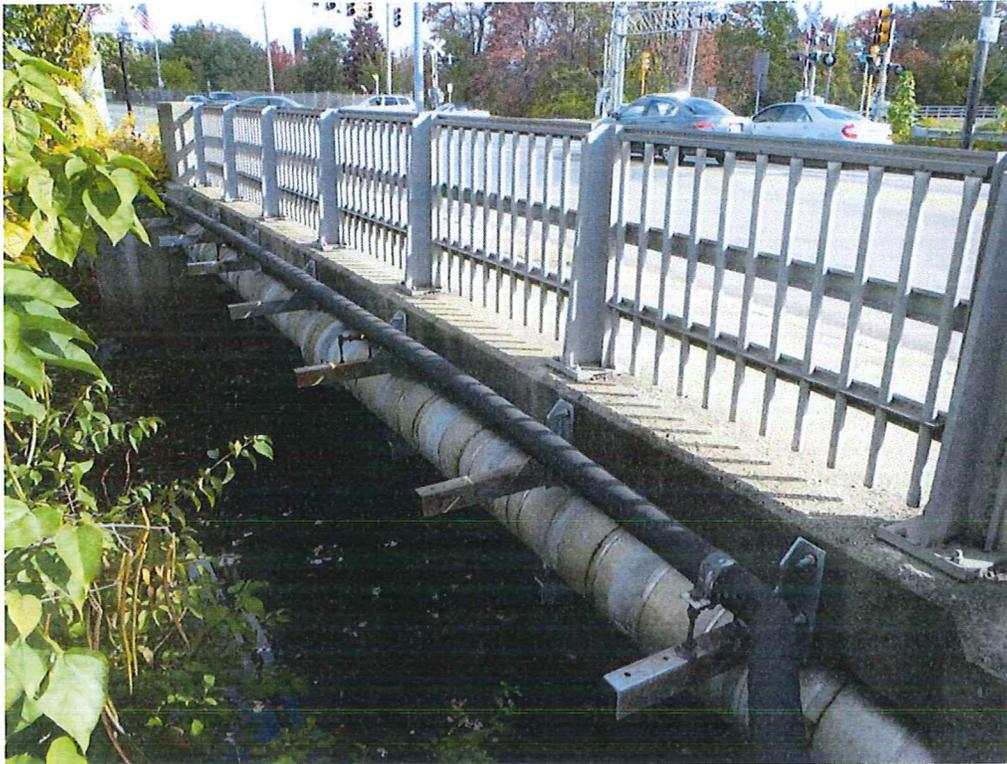
Photo 5: Utility west side of bridge. Seven brackets, 1 and 7 intact, 2, 4 and 6 missing, 3 and 5 missing straps. Numbered south to north.
