APPENDIX D

Drawings and Inspection Reports of Bridges in Area

Armstrong Dam Removal Feasibility Study

BRIDGE NO. B-21-041

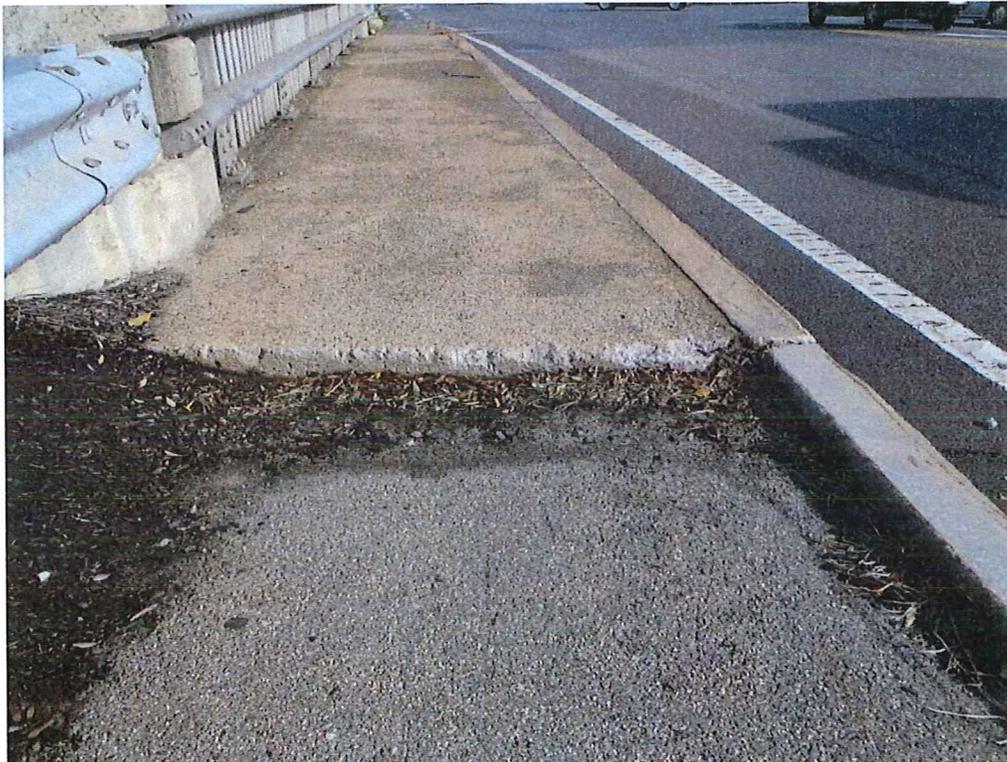
Photo 6: Settlement 5-1/2" at southwest approach sidewalk.

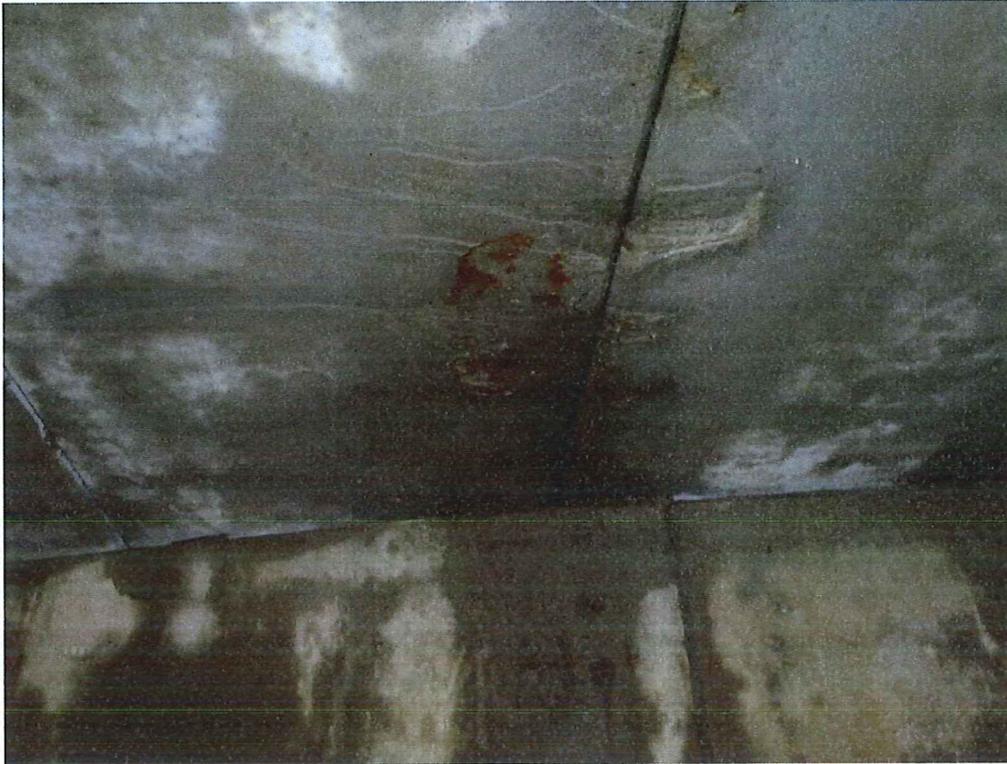
Photo 7: Beam 9 at bottom face by south breastwall new minor spall with rebar exposed, delamination with rust stains.

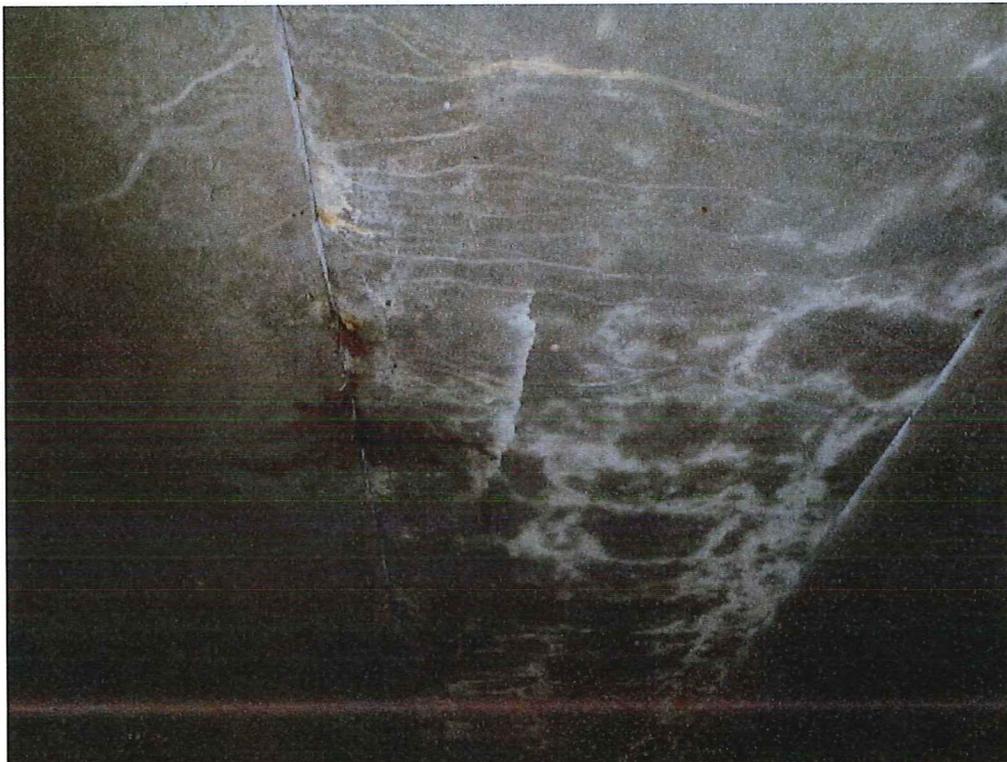
Photo 8: Cracking with delamination and rust staining at the midspan of beam 9.

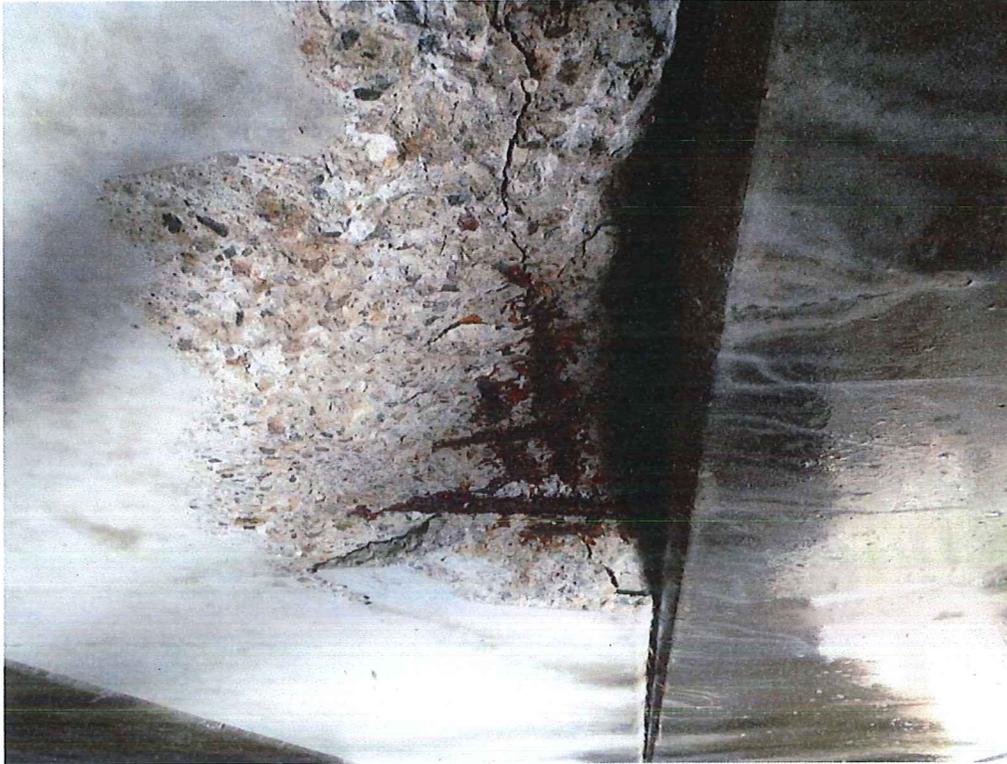
Photo 9: Beam 16 adjacent to beam 17 at midspan, spall 3' 5" L x 18" W x up to 4-3/4" D with cracking and delamination.

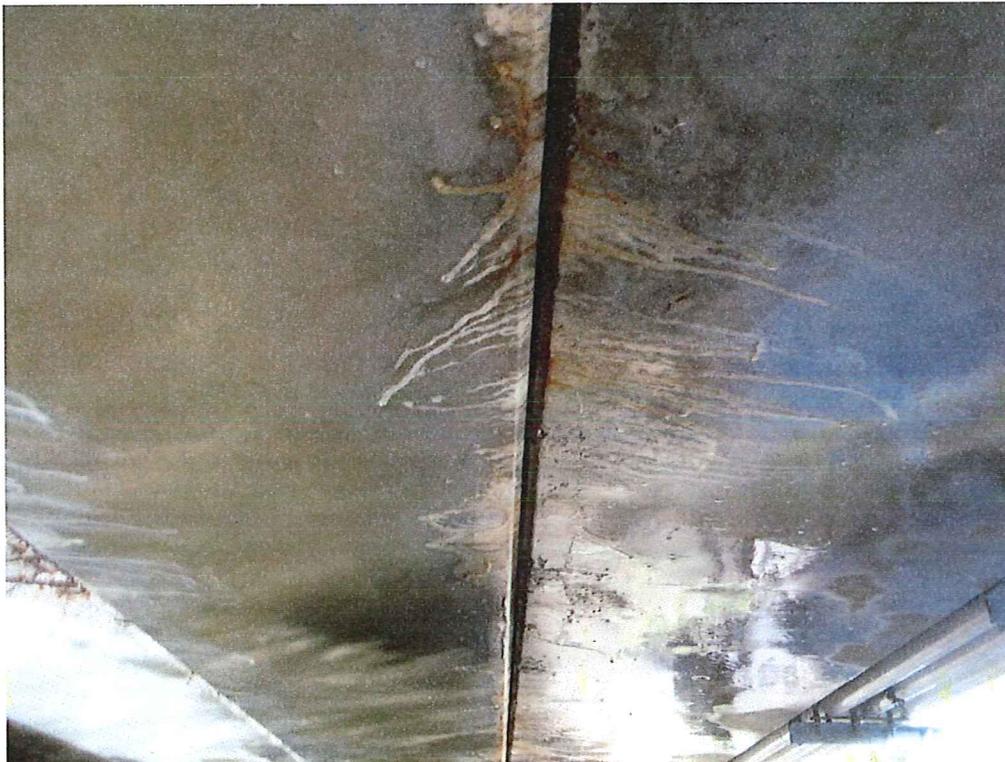
Photo 10: East end beneath last two beams 17 and 18 showing leakage.

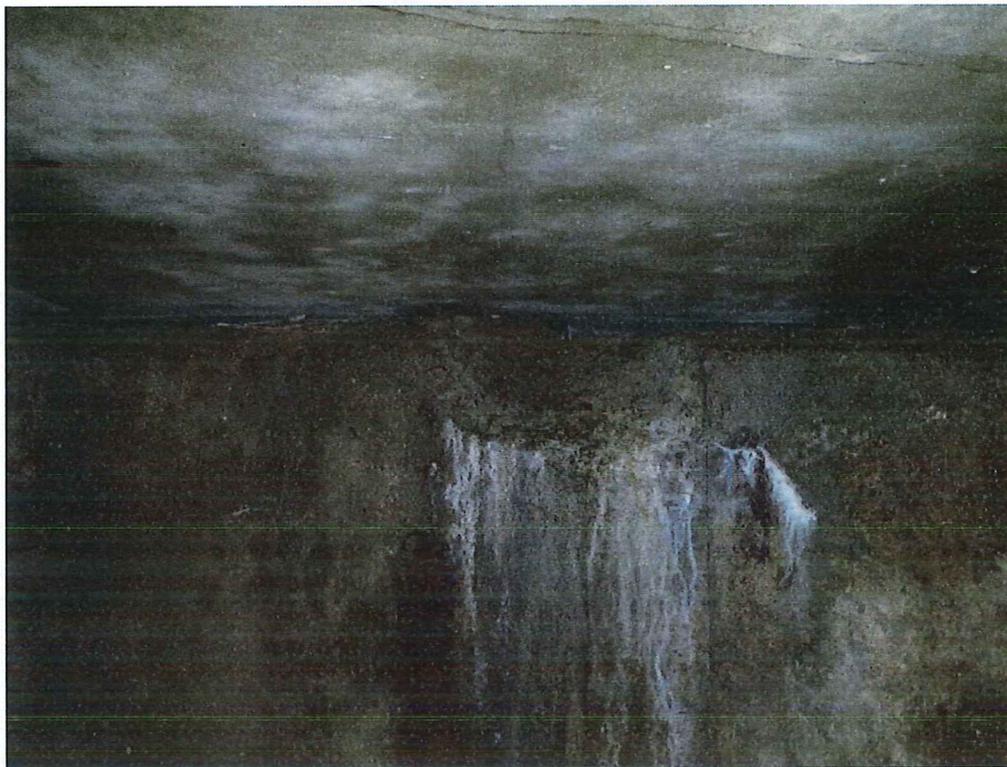
Photo 11: South breastwall, spall under beam 2, 1' H x 8" H x up to 4" D. Below spall, two rust stains with hairline cracks with efflo. between.

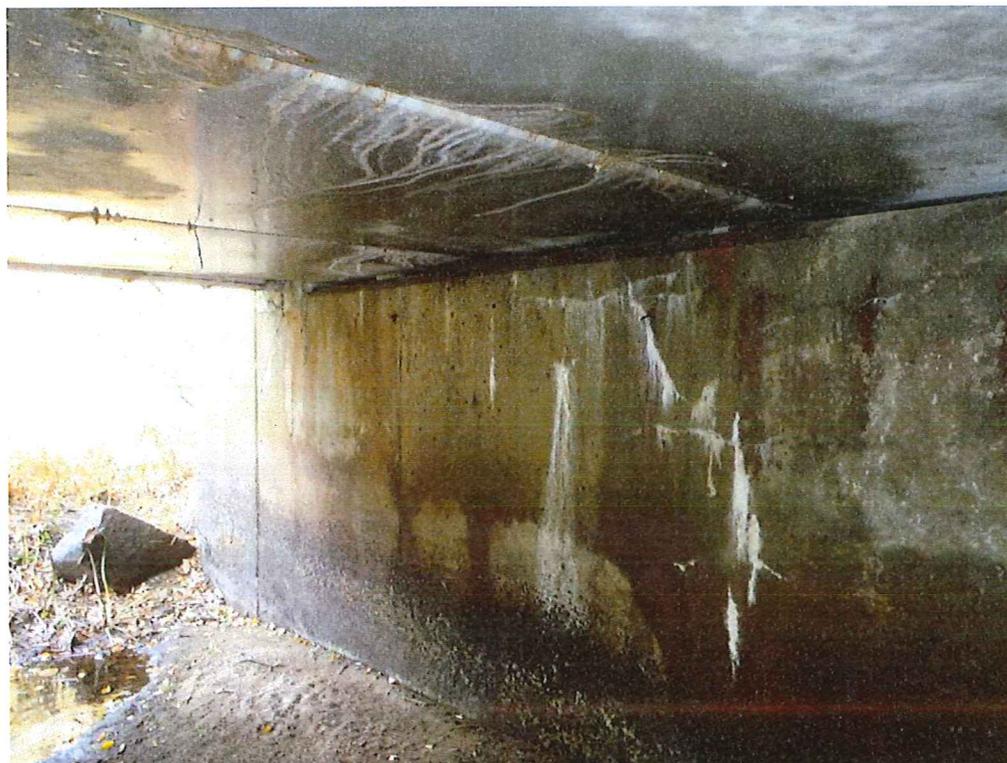
Photo 12: North breastwall, west end. Typical cracking with rust staining and efflorescence at top of both breastwalls.

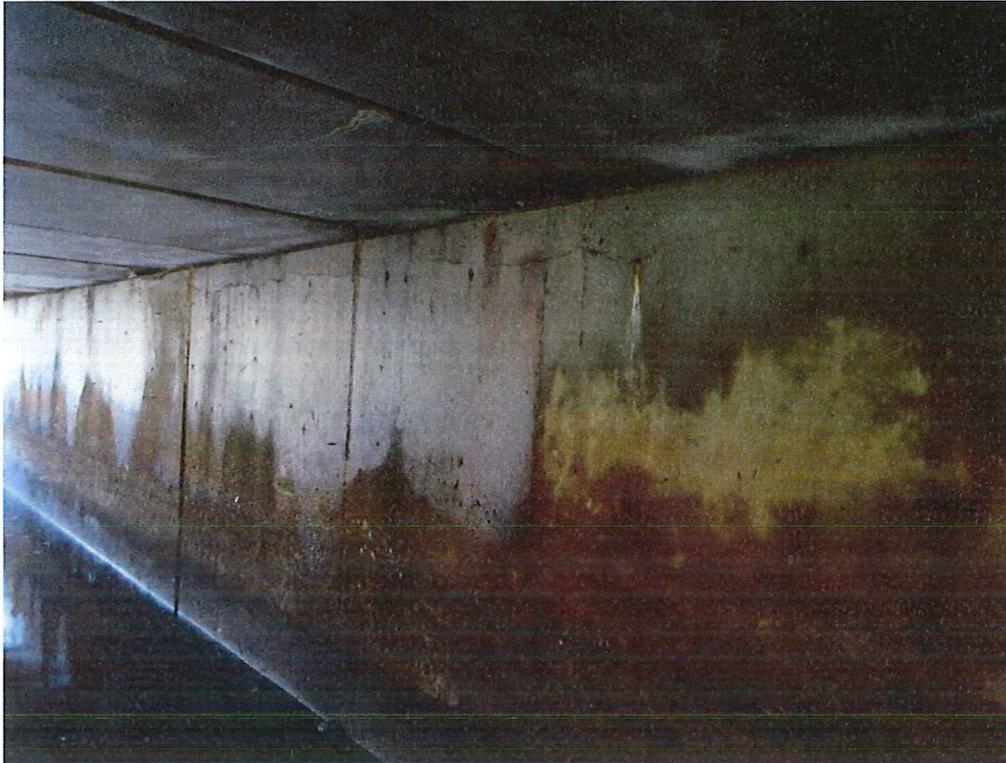
Photo 13: Typical cracking at the top of the breastwalls approximately 1' under the deck beams.

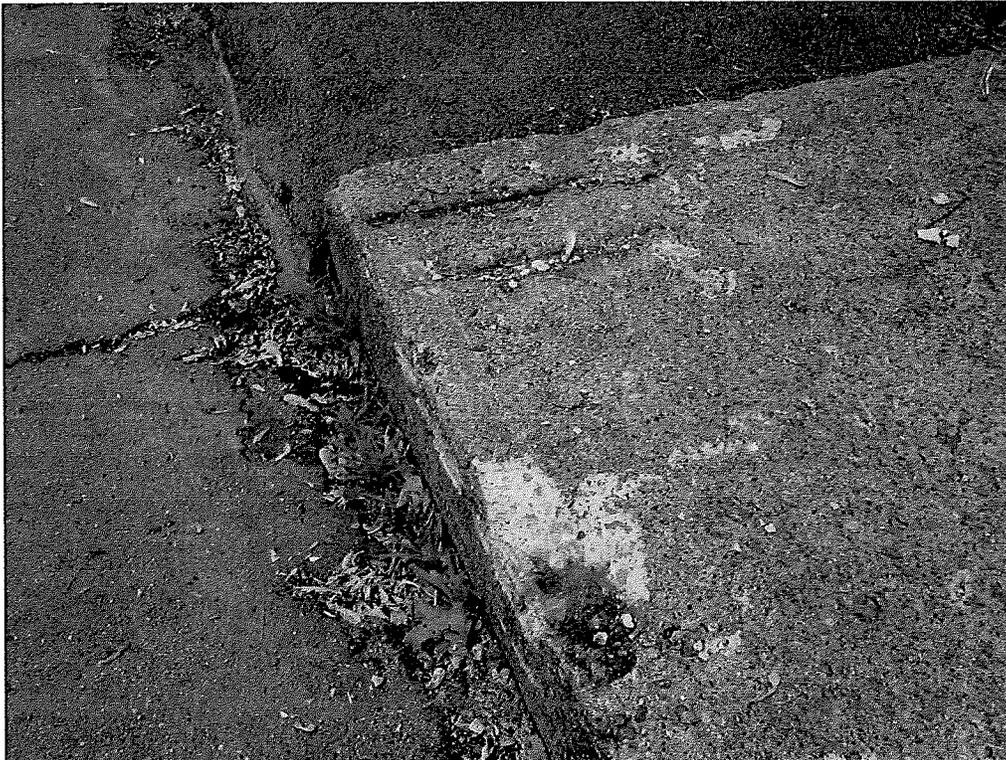
Photo 2: Sidewalks - Top side north sidewalk west end and adjacent to curb, three minor spalls with rusted rebar exposed.

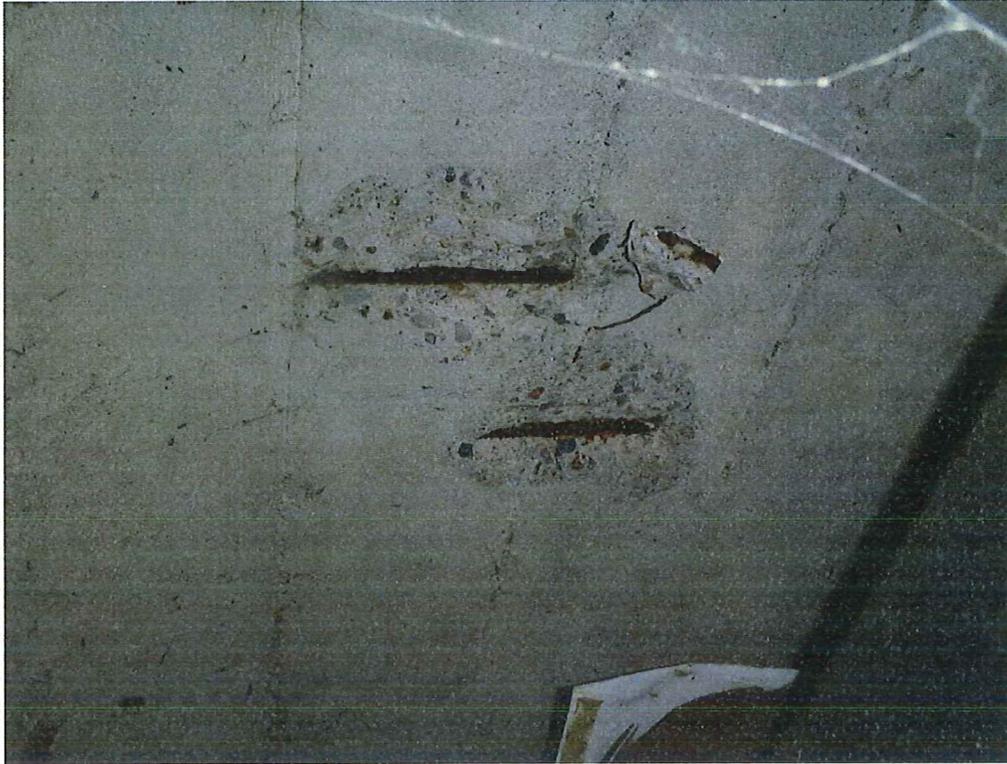
Photo 3: Sidewalks - Underside of the north sidewalk by the east abutment, two minor spalls with rusted rebar exposed with delamination.

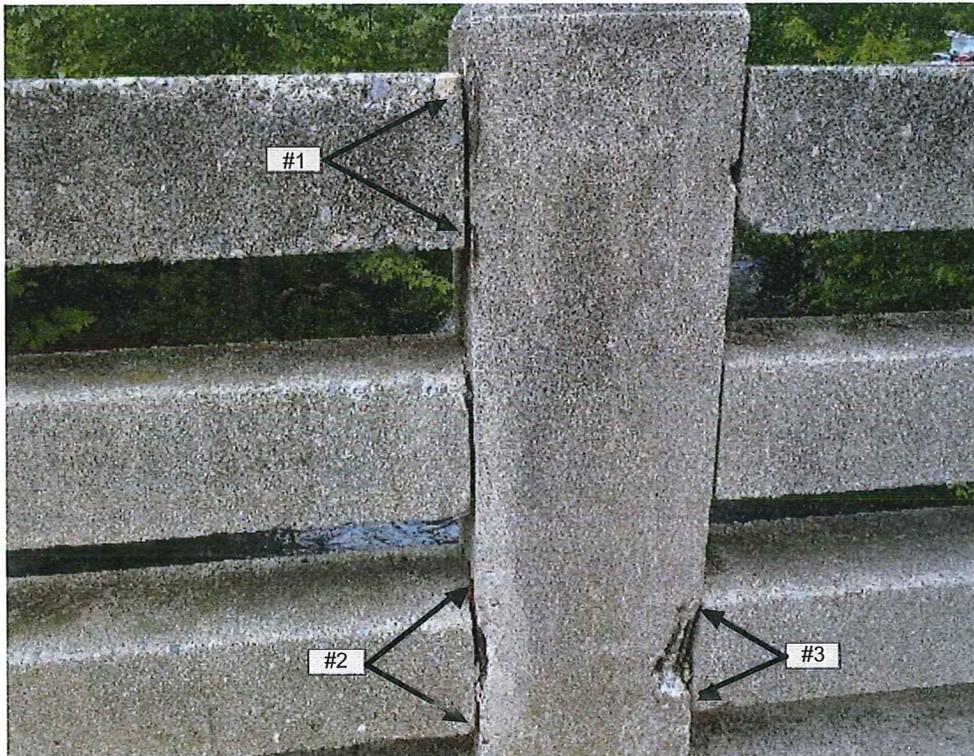
Photo 4: Railing - North railing middle post, three (3) minor spalls with rusted rebar exposed due to insufficient cover.

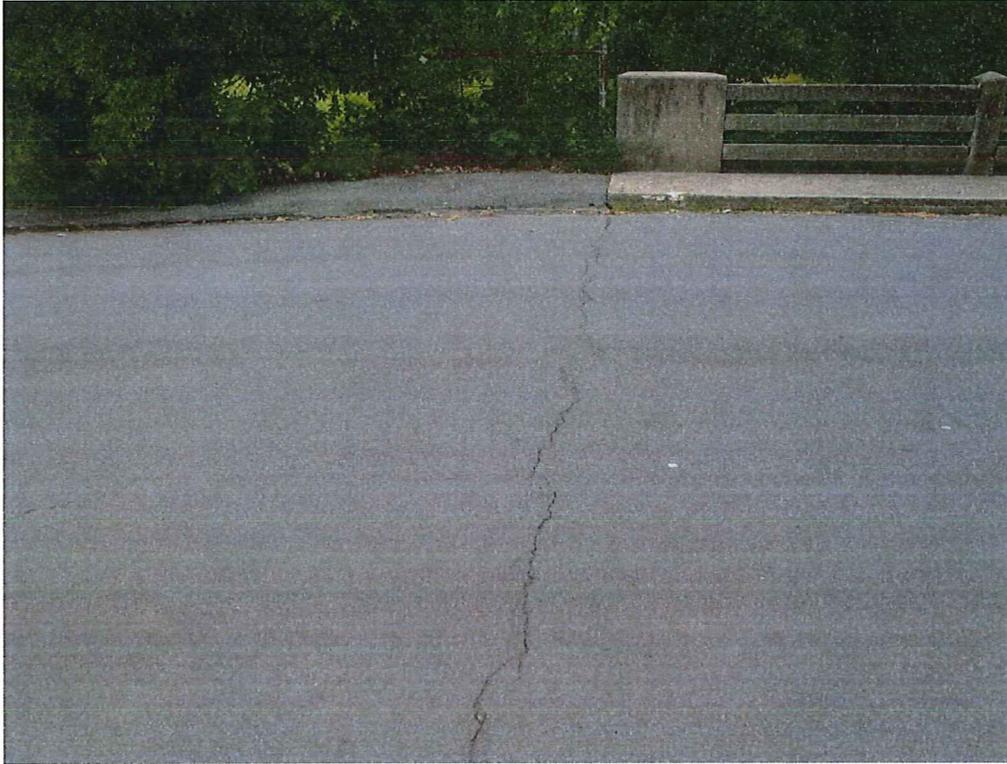
Photo 5: Approaches - West approach, full width transverse 1/8" crack over the west abutment.

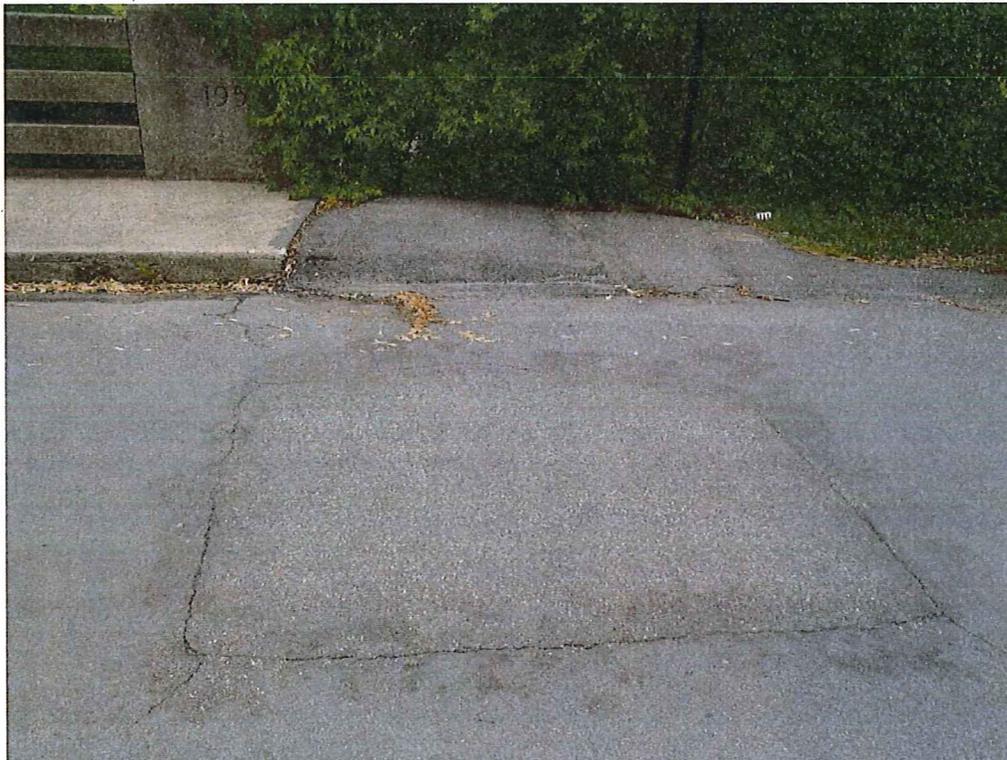
Photo 6: Approaches - East approach westbound roadway adjacent to east abutment just off north approach curb, 6' x 7' bituminous patch.

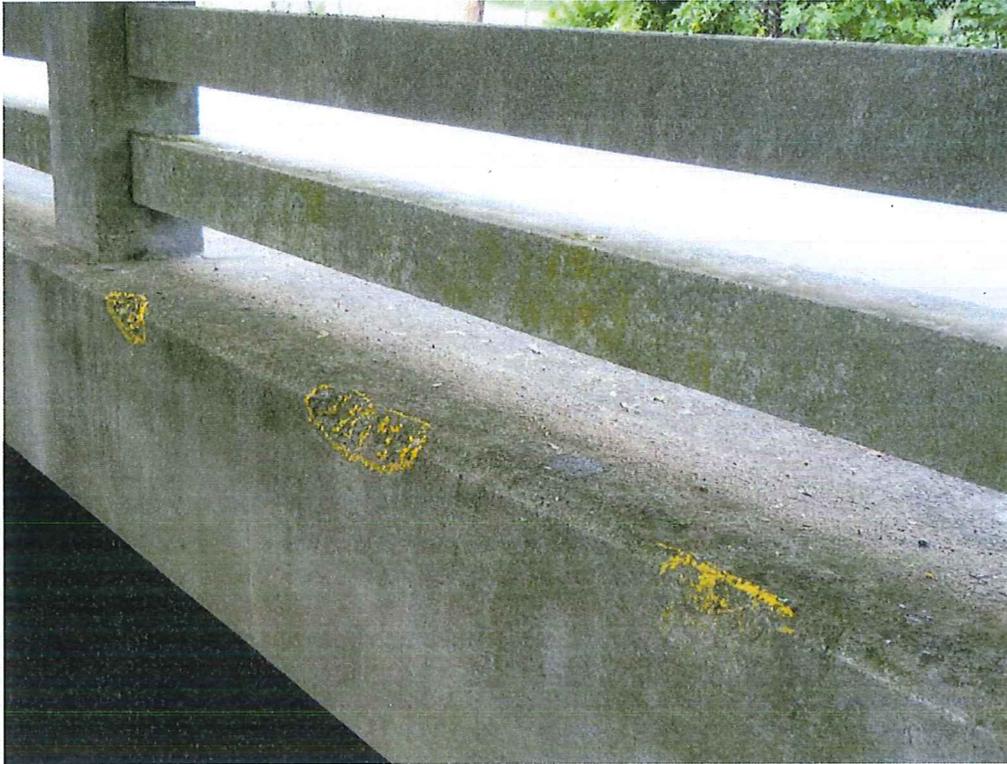
Photo 7: Beams - South fascia beam south face top corner east half, three (3) minor spalls.

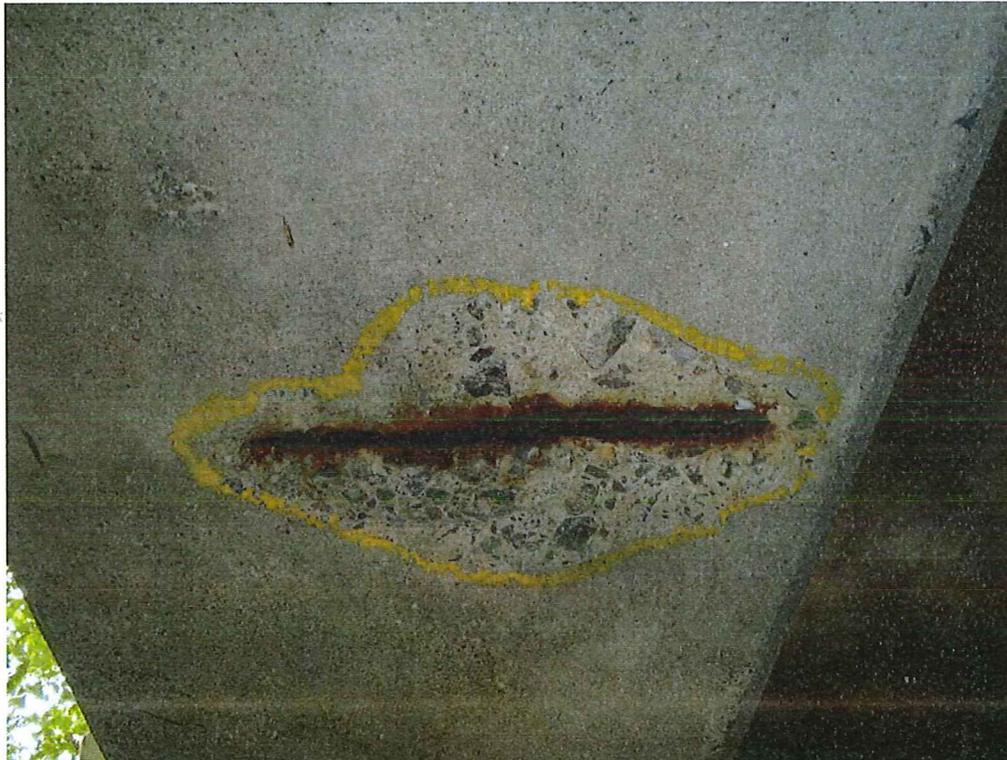
Photo 8: Beams - South fascia beam underside face, minor spall with rusted rebar exposed approximately 9' from the east abutment.

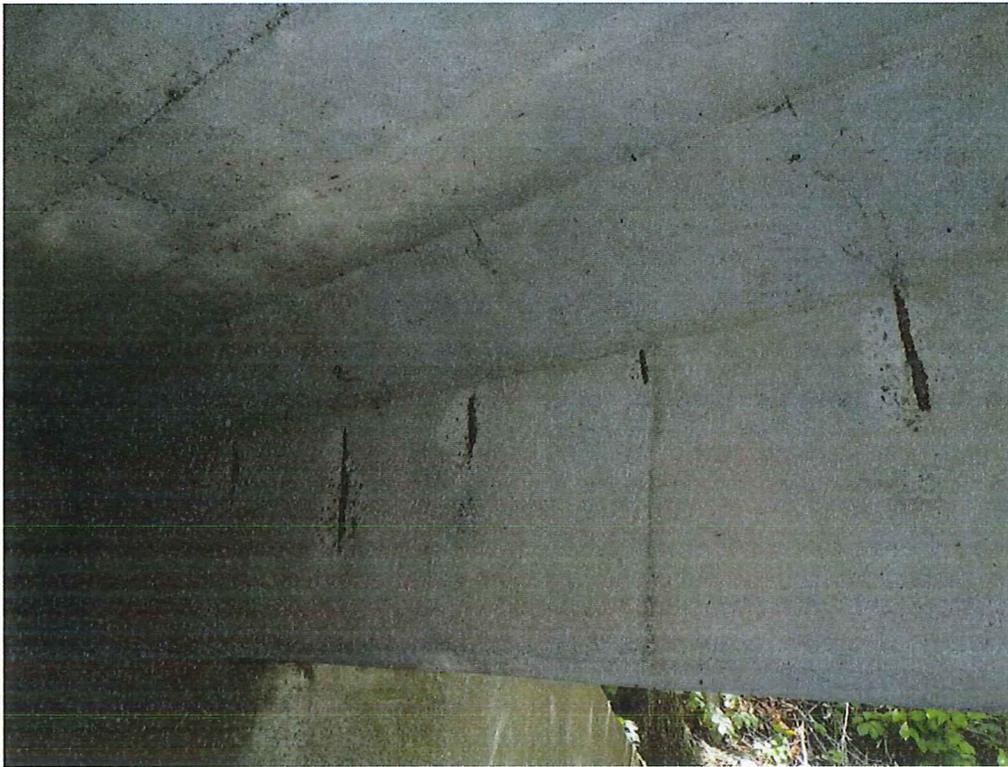
Photo 9: Beams - South fascia beam north face east half, minor spalls with rusted rebar exposed.

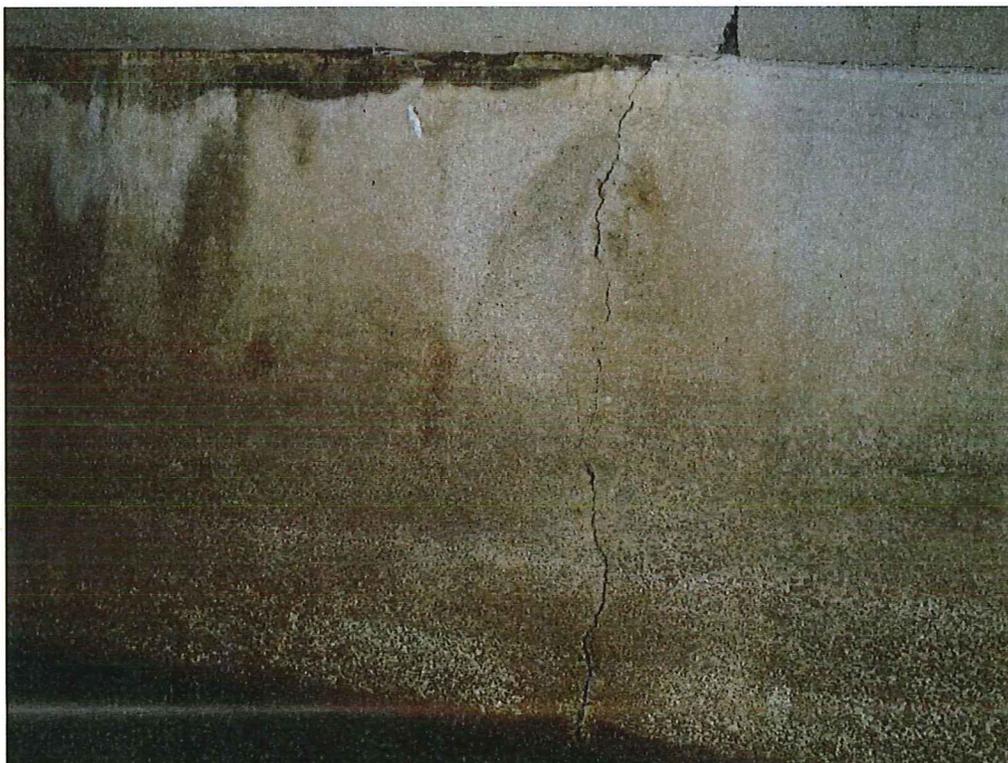
Photo 10: Breastwalls - Full-height vertical crack at the east breastwall below the south end of the slab

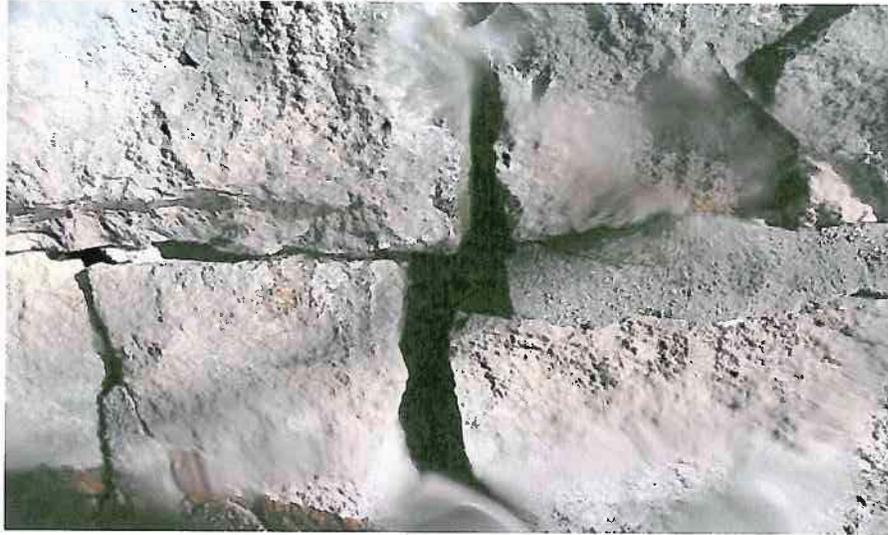
Photo 001

North Abutment - missing mortar (typ)

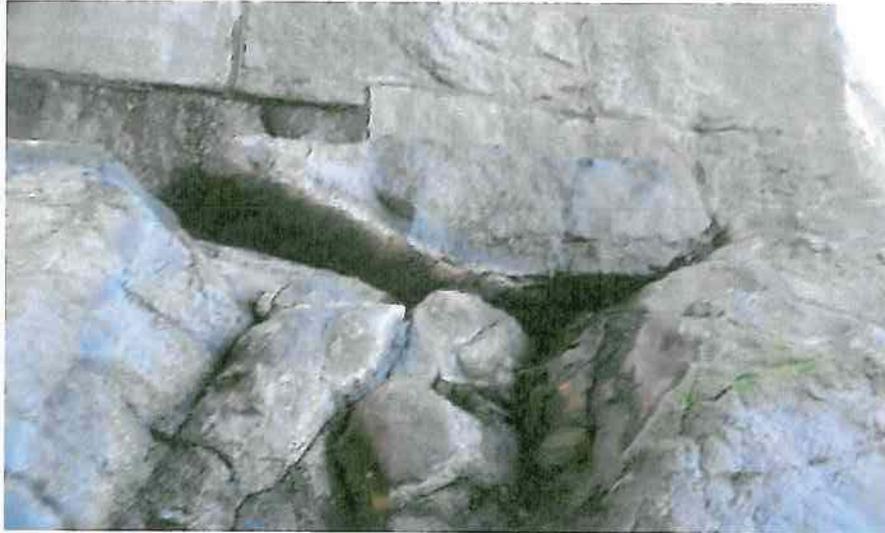
Photo 005

South Footing - 1.7' wide fracture and loose stone on top.

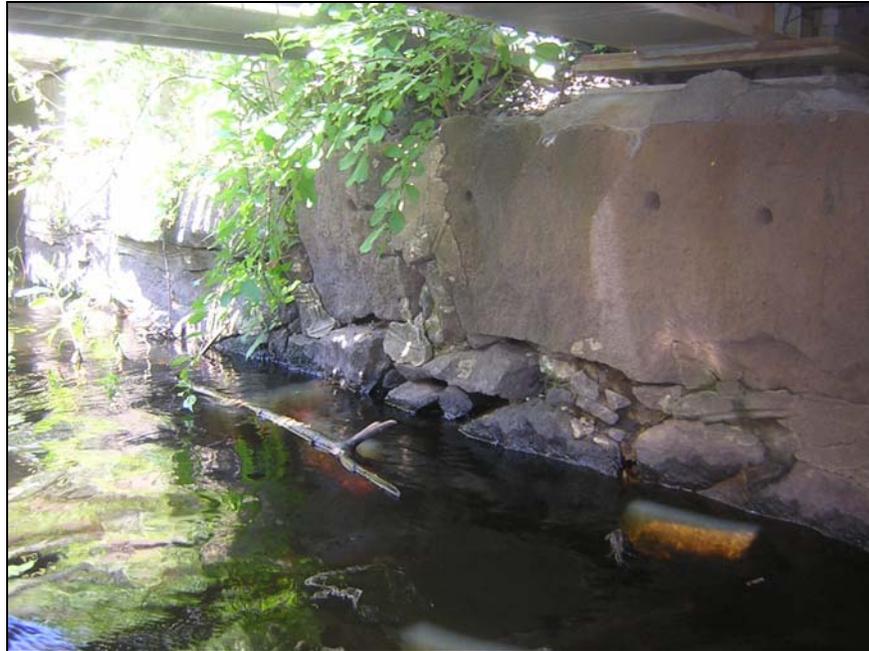
Photo 3-North abutment loose/missing mortar and chink stones with vegetation growth

The voids and the loose, missing, cracked mortar joints of the abutments, wingwalls, and piers should be repaired to prevent further deterioration. These areas can be repaired by chipping away at the deteriorated mortar, cleaning and repointing. The corrugated drain pipe should be repaired to prevent further fill material loss from behind the abutment. The pipe can be sleeved and the voids filled with a non-shrink grout. The vegetation and undergrowth on the abutments should be removed to prevent further deterioration and separation of the mortar joints. The debris pile should be removed and riprap should be placed along the pier faces to prevent further scouring along the pier faces.

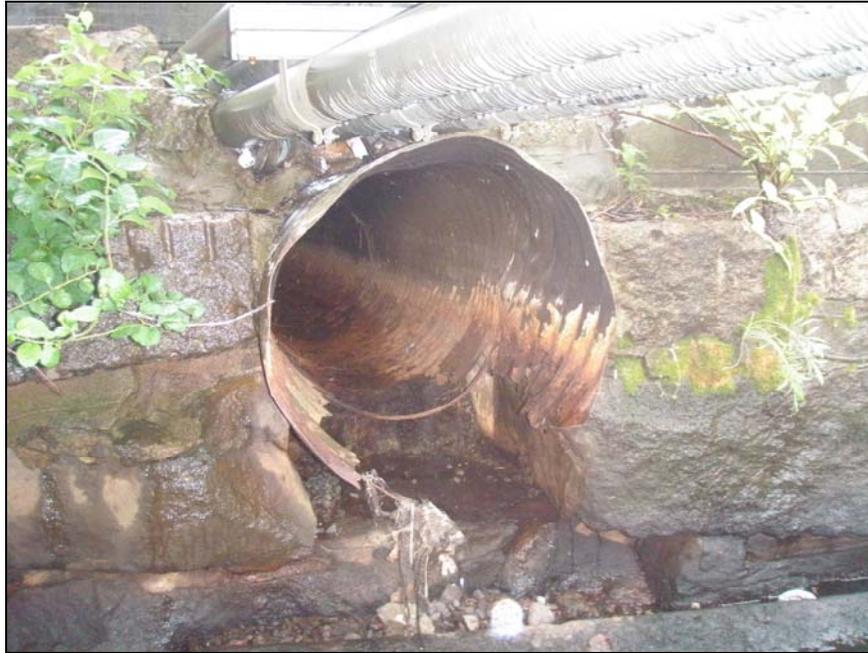
Photo 4- South abutment, corroded and undermined the drainage pipe.

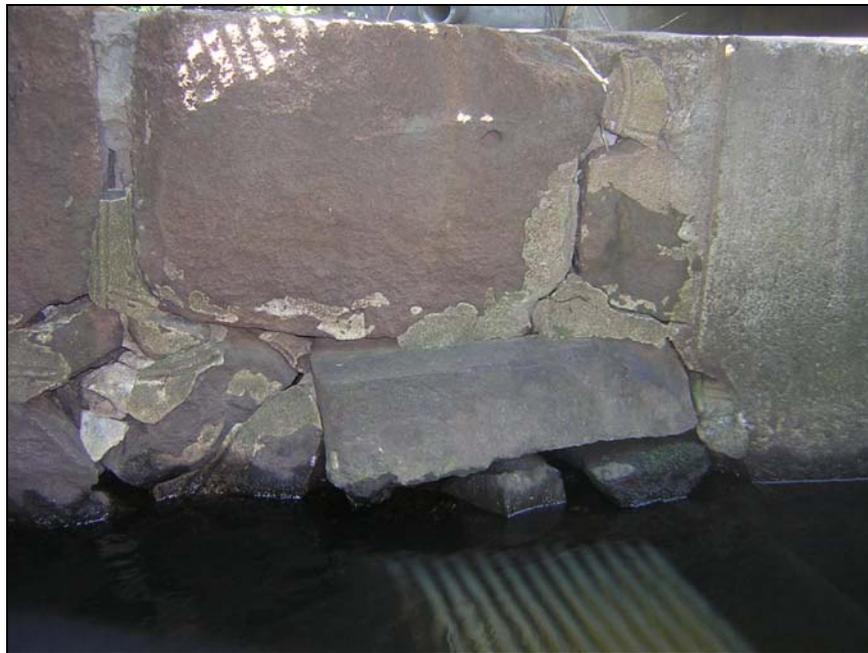
Photo 5- Pier 1, North face, failed and missing mortar

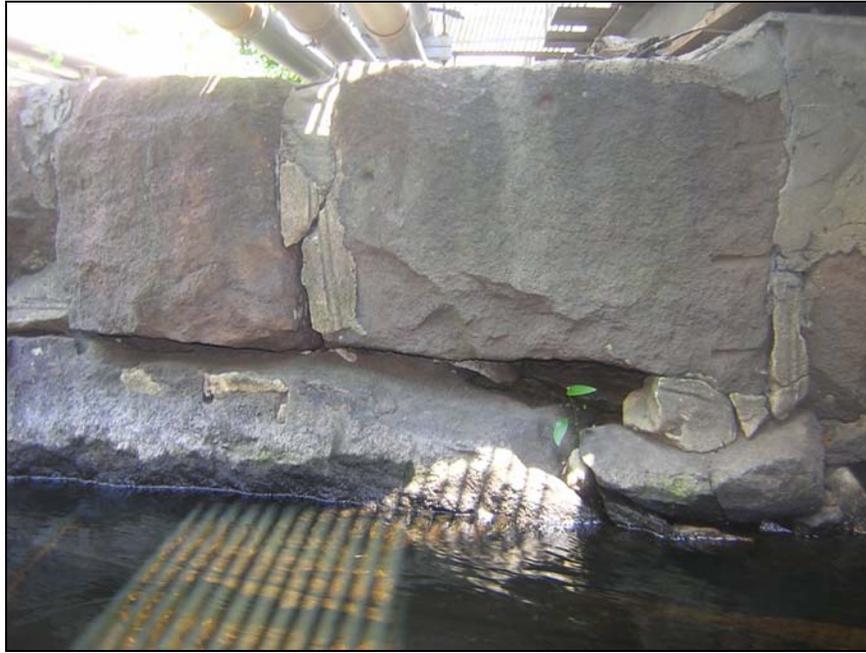
Photo 6- Pier 2, south face, failed and missing mortar

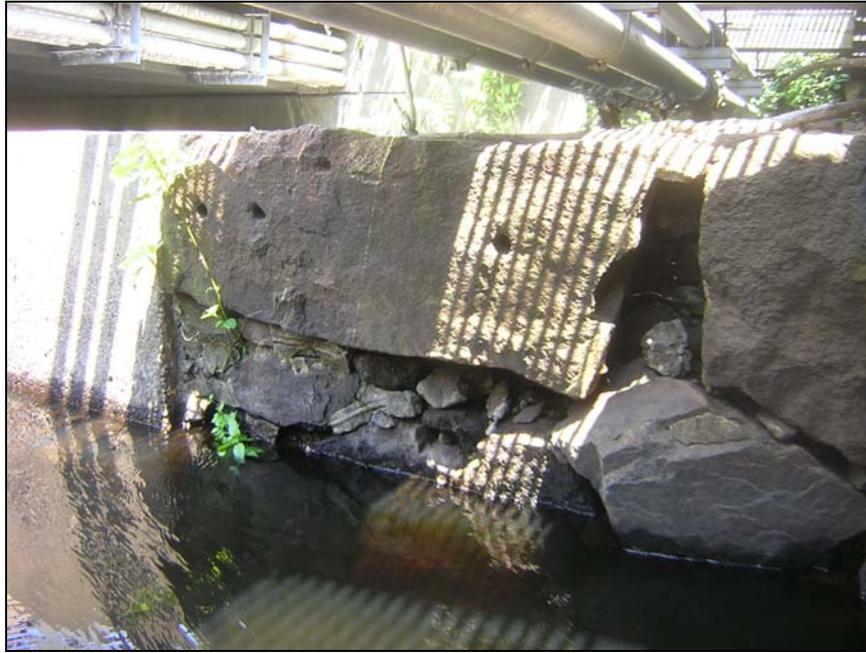
Photo 8- Pier 1, southwest side, 6' L x 14" D section of missing mortar and loose chink stones

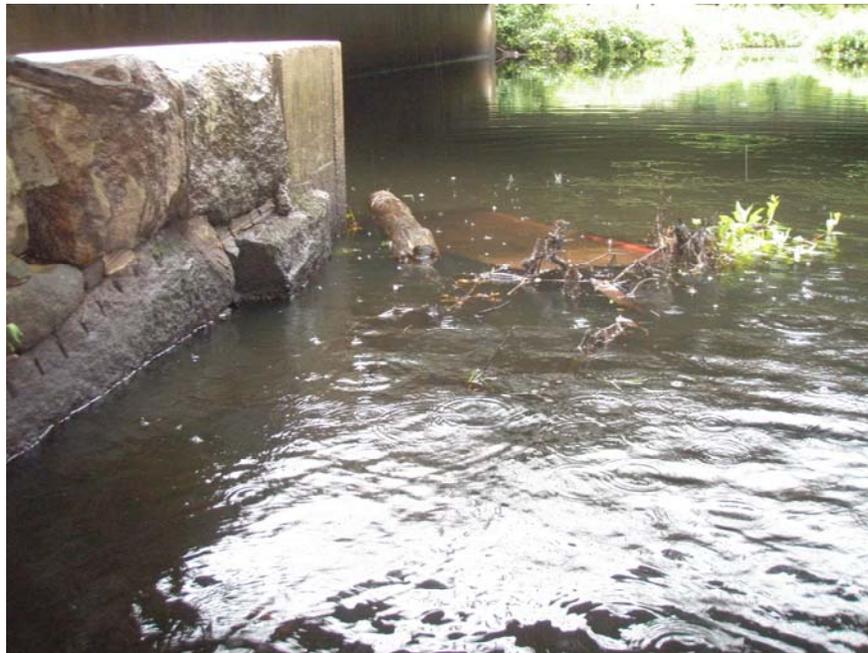
Photo 9- Debris pile between Piers
