APPENDIX D

Drawings and Inspection Reports of Bridges in Area

Armstrong Dam Removal Feasibility Study

BRIDGE NO. B-21-041

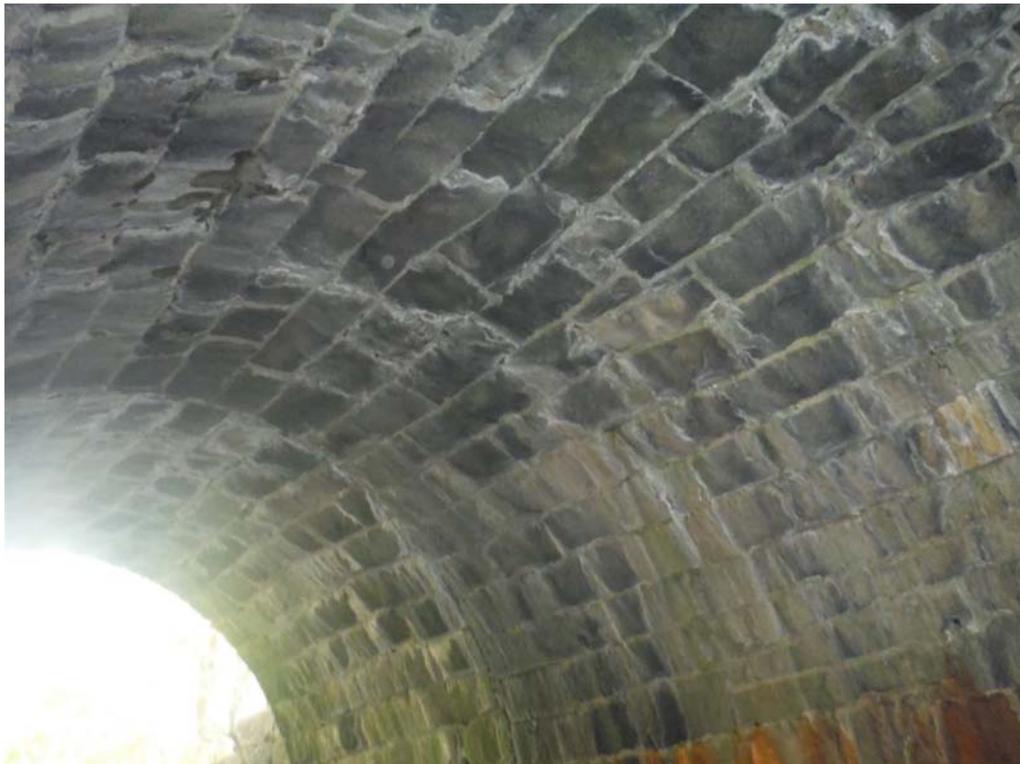
(Fair); The arch exhibits moderate to heavy efflorescence and missing mortar throughout the underside with the heaviest efflorescence occurring at the 15'-0" section east of the construction joint. **(See photos 8, 13, & 14)** The construction joint between the two portions of the arch is between 3"-4" wide. Several isolated stones were found to be cracked throughout the structure. A 1/8" crack is present on the North section of the arch. The crack is approximately 10ft from the west fascade and extends from the springline to the crown. **(See photo 15)** The crack does not appear to have changed since the last inspection report. The eastern fascade stones are pulling away from the arch. The gap between stones is as large as 2.5" and extends from the south springline to the north springline. **(See photo 16 & 17)** The previous inspection report describes this separation as 1.5" wide.

Photo 8: Typical underside of bridge

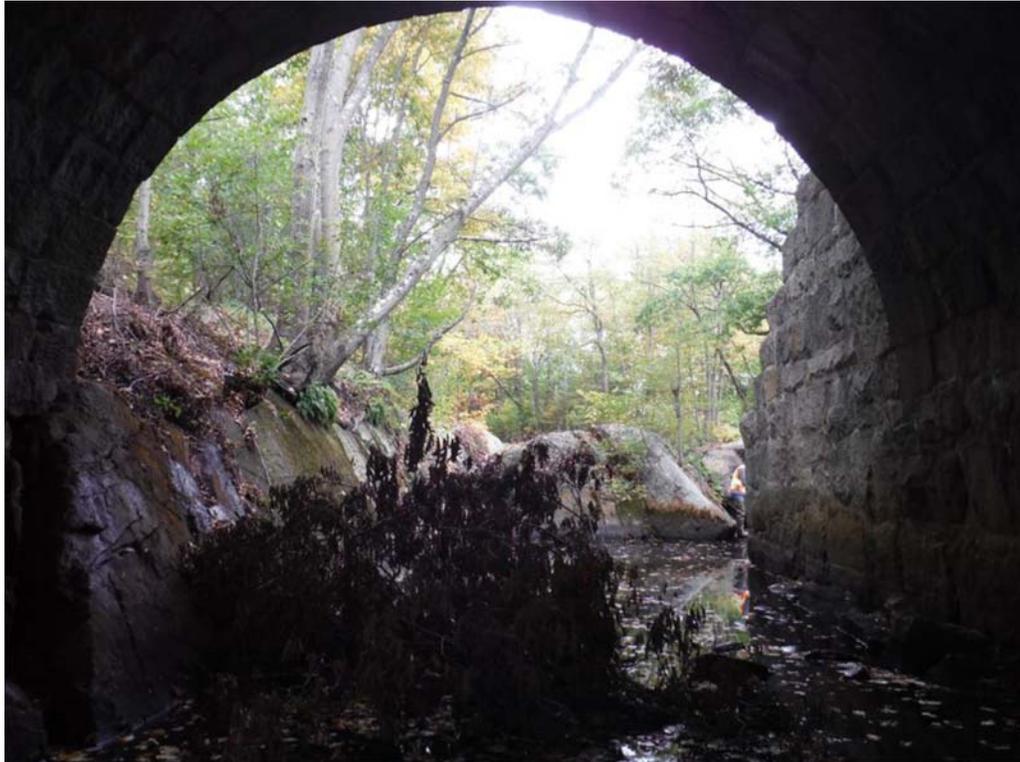
Photo 11: Debris in stream at upstream end of bridge

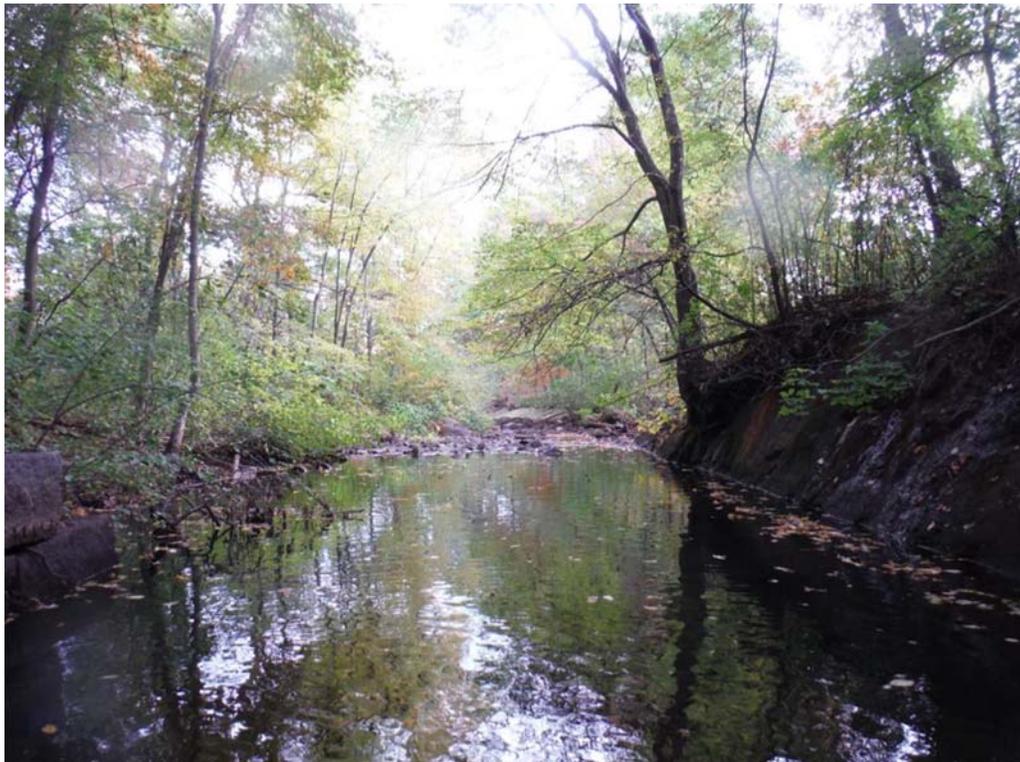
Photo 12: Minor bank erosion downstream

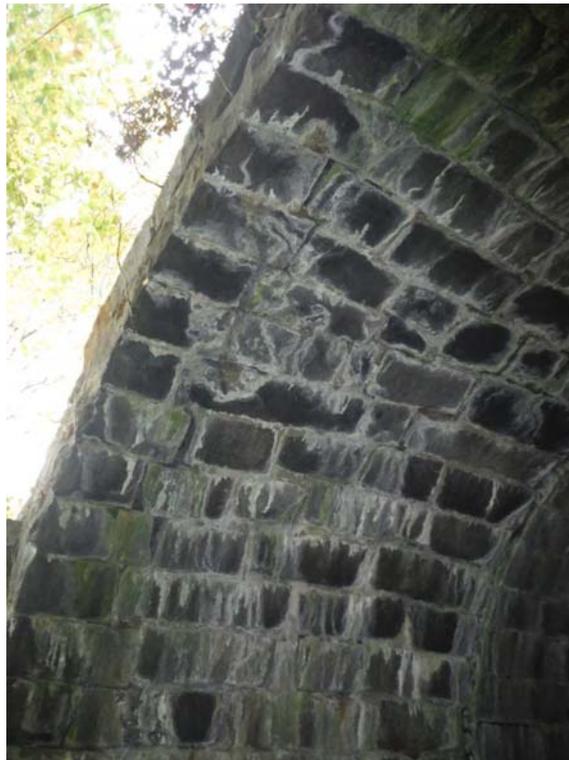
- Photo 14 : Typical missing mortar throughout underside of structure
- Photo 15 : Crack in north section of arch from springline to crown
- Photo 16 : East fascia stones separating from arch looking south

Photo 16: East fascia stones separating from arch looking south

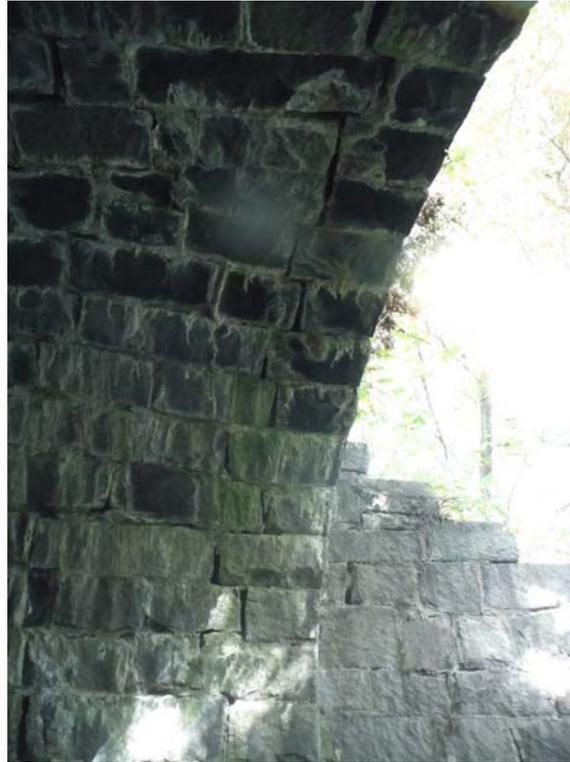
- Photo 17 : East fascia stones separating from arch looking north
- Photo 18 : East spandrel wall missing stone and missing mortar
- Photo 19 : Original underside with irregular shaped stones

Photo 17: East fascia stones separating from arch looking north

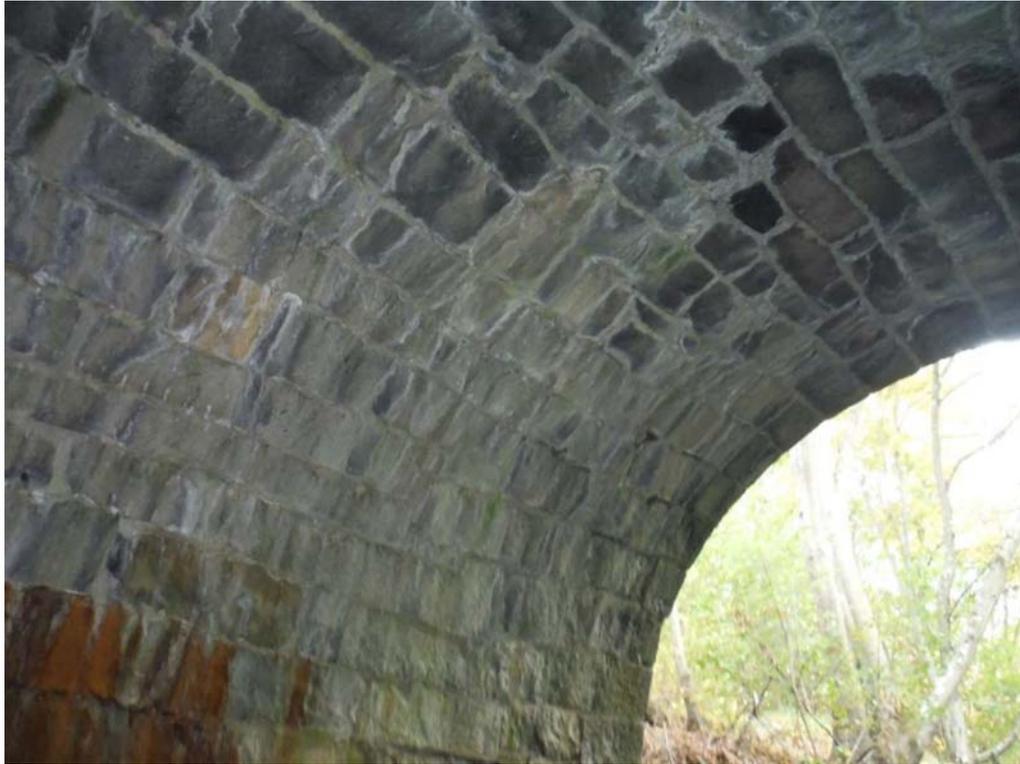
The original portion of the arch contains irregular shaped stones **(See photo 19)** The 15'-0" addition to the arch contains more regular shaped stones arranged in a more organized pattern.

Photo 19: Original underside with irregular shaped stones

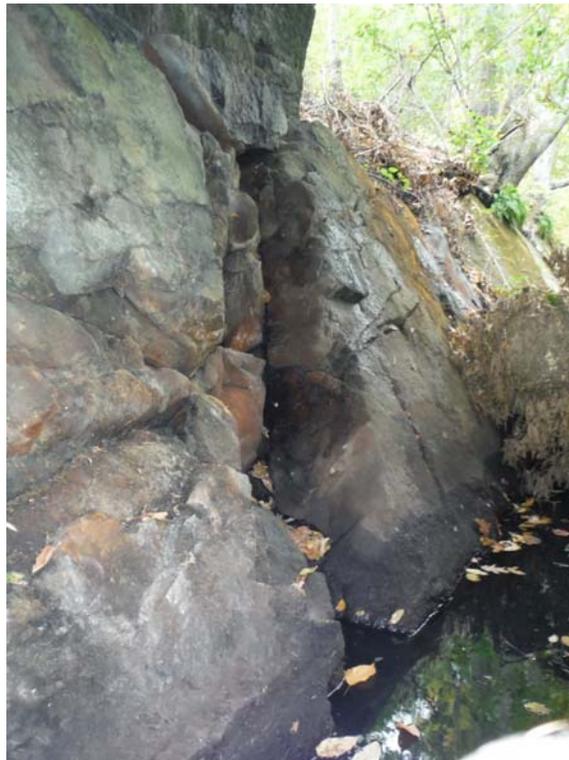
- Photo 20 : Irregularity in stone foundation near southwest abutment corner
- Photo 21 : Missing mortar and heavy vegetation growth at southeast wingwall

Photo 20: Irregularity in stone foundation near southwest abutment corner

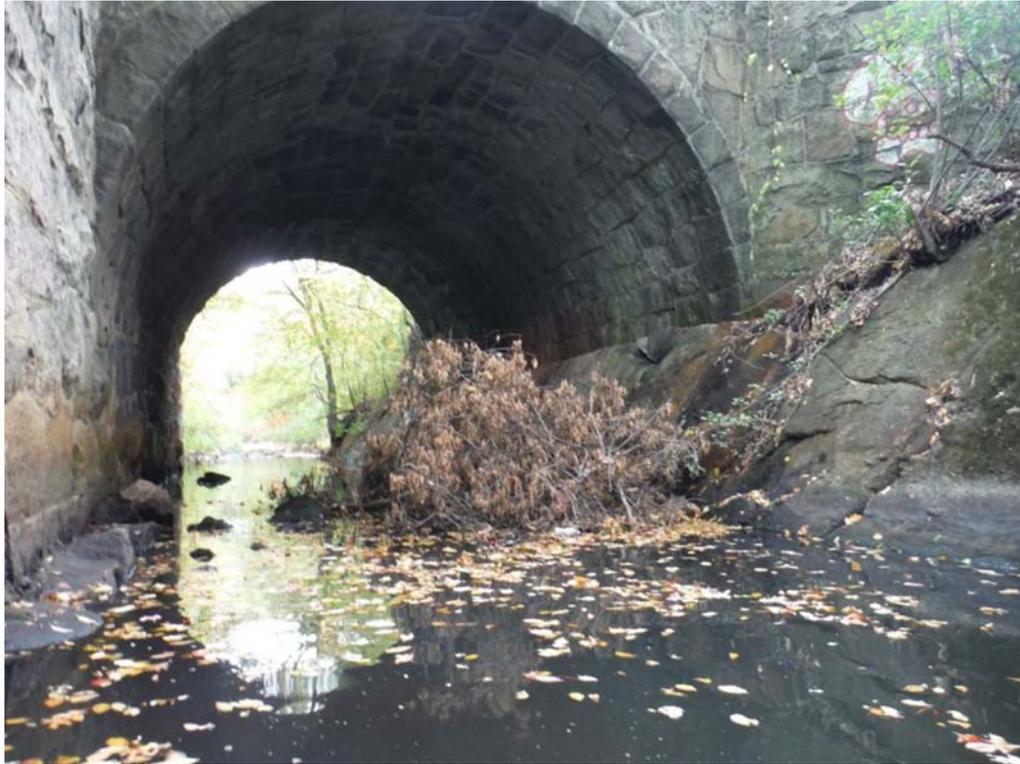
- Photo 22 : Cracked and missing stone directly below southeast wingwall
- Photo 23 : Debris in waterway along the southwest entrance to the structure
- Photo 24 : Northeast wingwall elevation

Photo 23: Debris in waterway along the southwest entrance to the structure

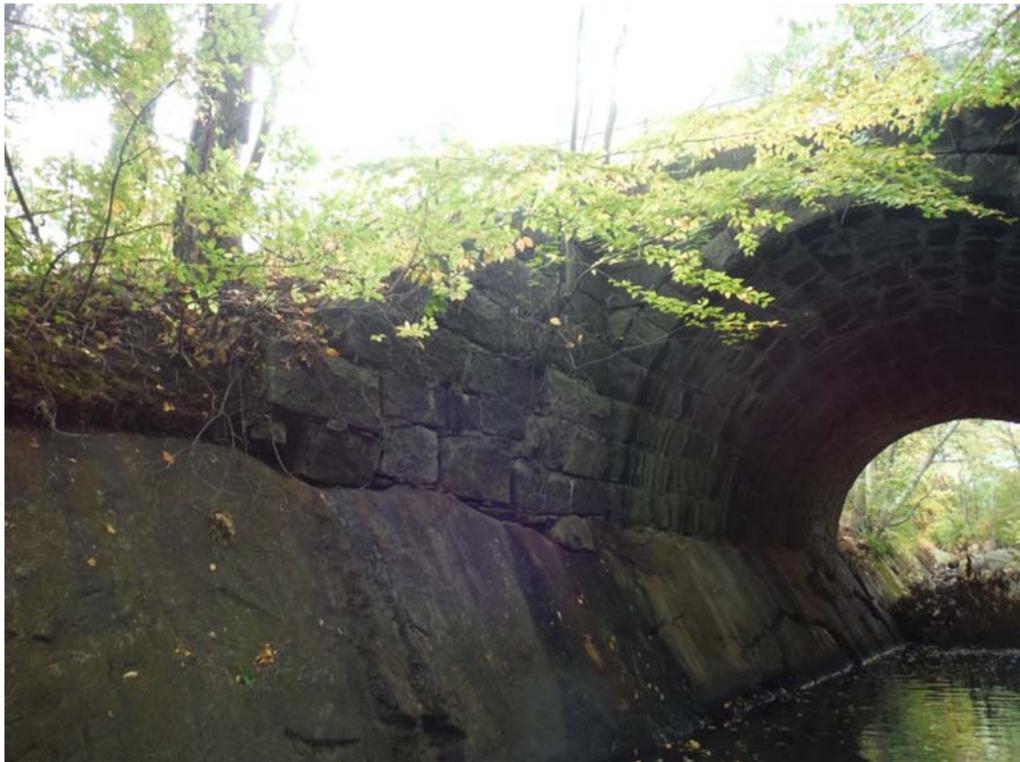
Photo 26: Southeast wingwall elevation

- Item 59.10 - **Masonry Joints**; Extensive cracked, loose, and missing mortar.
 - Item 60.1.g - **Pointing**; Extensive cracked, loose, and missing mortar at wingwalls. Focused at the southeast wingwall.

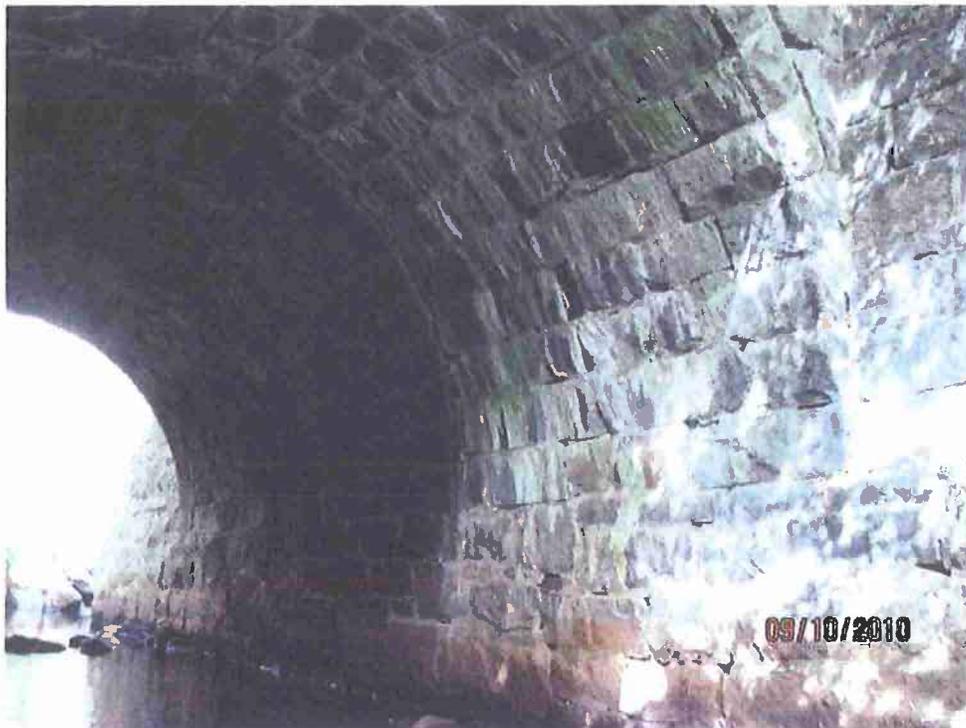
The original portion of the arch barrel consists of irregularly shaped stones that exhibit heavy efflorescence and areas of loose stones and missing mortar. The 15' – 0" eastern portion of the barrel consists of stones that are more regularly shaped however it still exhibits heavy efflorescence and loose stones and missing mortar. The construction joint between these two portions is up to 3" to 4" wide. The east fascia voussoir stones are pulling away from the arch barrel as noted by the circumferential gap, approx. 1" to 1.5" wide. An 1/8" wide vertical crack was found along the north half underside of arch approx. 10 ft from the west portal extending from the springline to the crown. Extensive ground water evidence is noted throughout the underside. The east spandrel wall was found to have missing mortar and a stone is missing from the north side.

Photo #6 – Arch Barrel – North Side Looking West

- Clean and re-point deficient masonry joints throughout.
- Replace missing stones in east spandrel wall.
- Continue to monitor the circumferential separation of the east fascia stones during subsequent inspections.
- Consideration should be given to installing a waterproofing membrane over the arch to stop the water seepage onto the arch blocks to prevent freeze thaw damage from deteriorating the granite block arch.

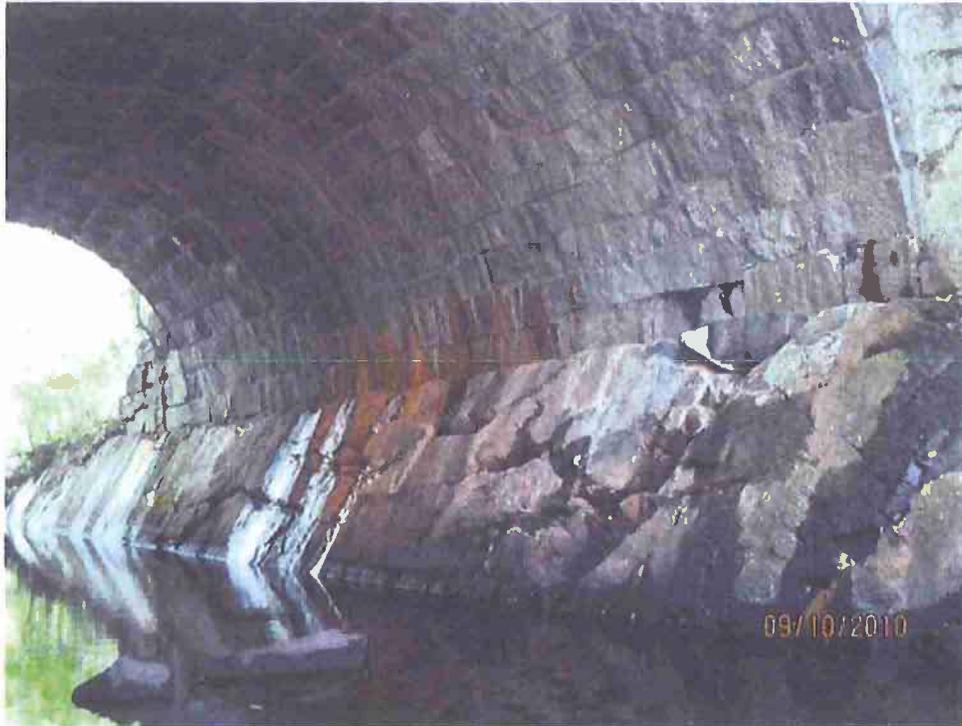
Photo #7 – Arch Barrel – South Side Looking East

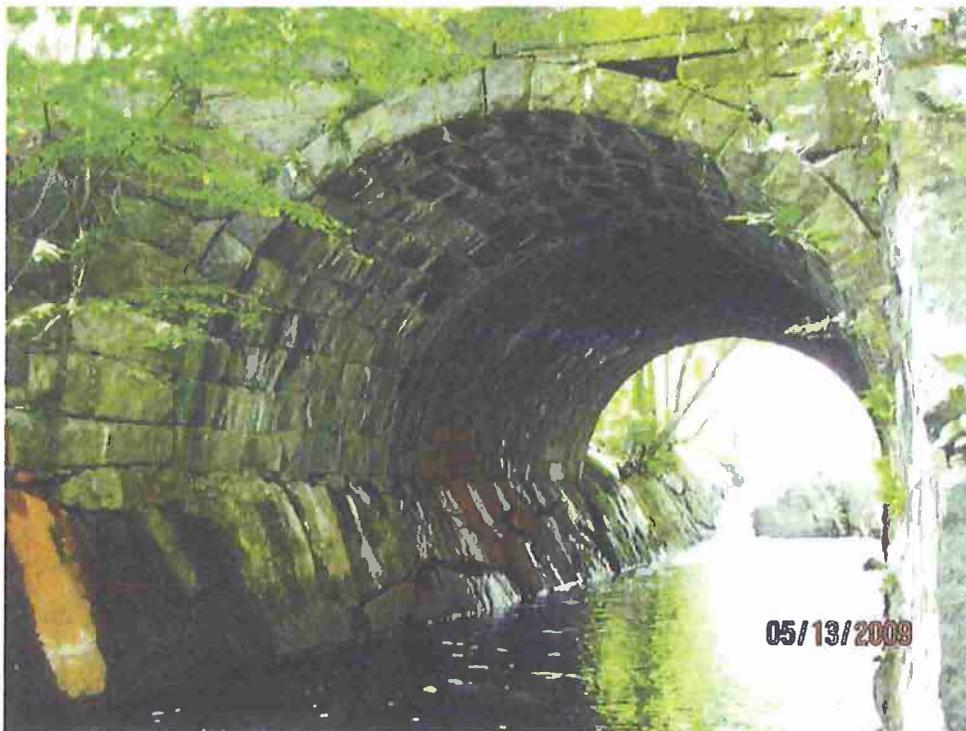
Photo #8– East Spandrel Wall

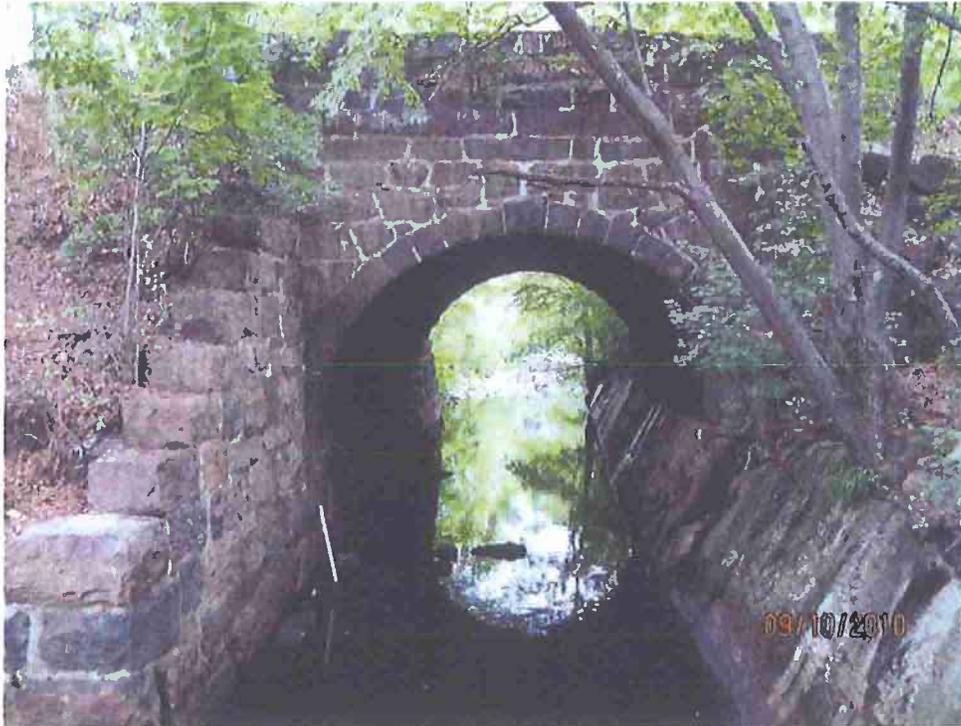
Photo #9 – West Spandrel Wall

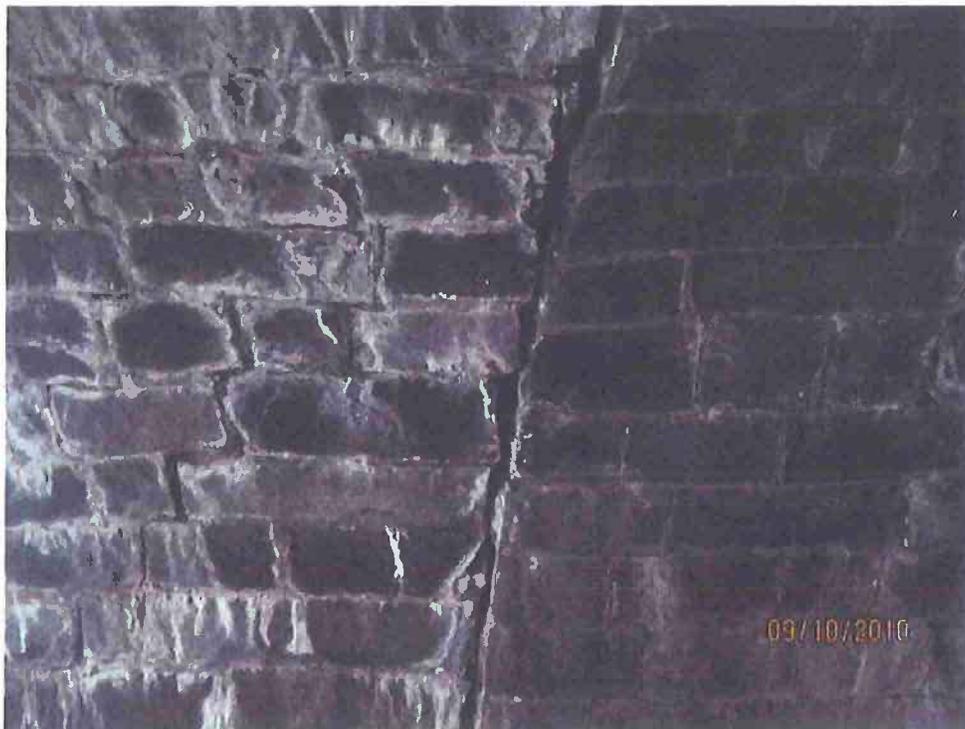
Photo #10 – Construction Joint between East and West Portions of Arch

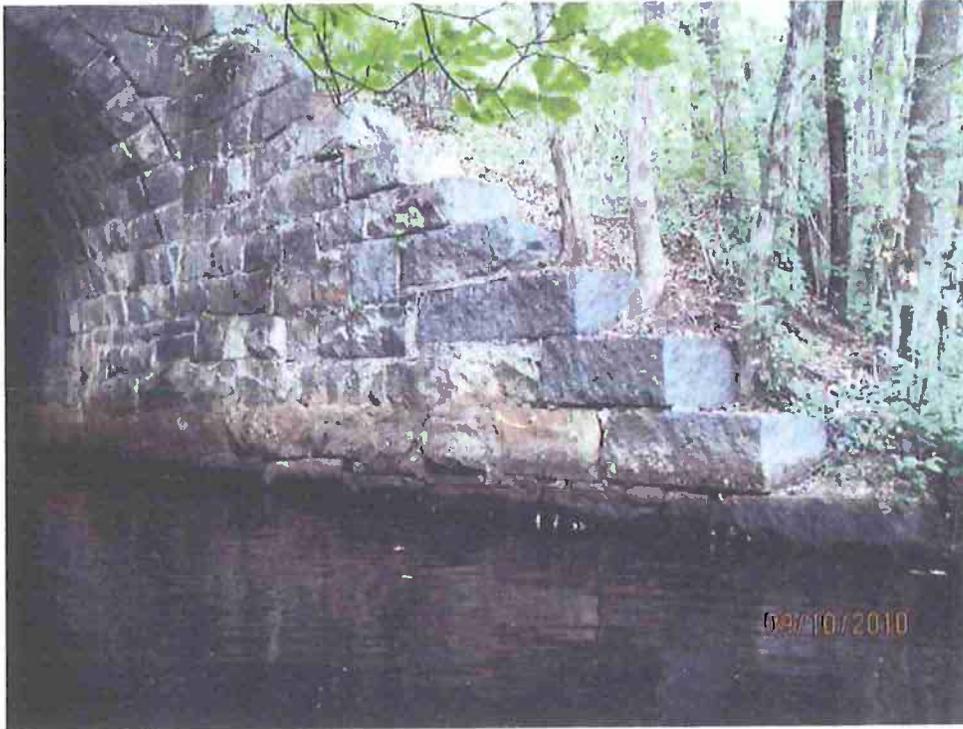
60.1b Wingwalls (Fair); The wingwalls consist of irregularly shaped stones and were found to be in fair to satisfactory condition. The Northeast and Southeast Wingwalls exhibit loose stones and missing mortar throughout. A stone was found to be missing on the Southeast Wingwall. The retaining wall behind the Southwest embankment retaining wall was found to have an area of undermining (see Photo 16). The Northwest Wingwall was found to be in good condition. The retaining wall on the northwest side of the bridge exhibits cracks in the mortar and loose stones (see Photos 12 to 15).

**Photo #13 - Northeast Wingwall**

- Clean and re-point deficient masonry joints and gaps between stones.

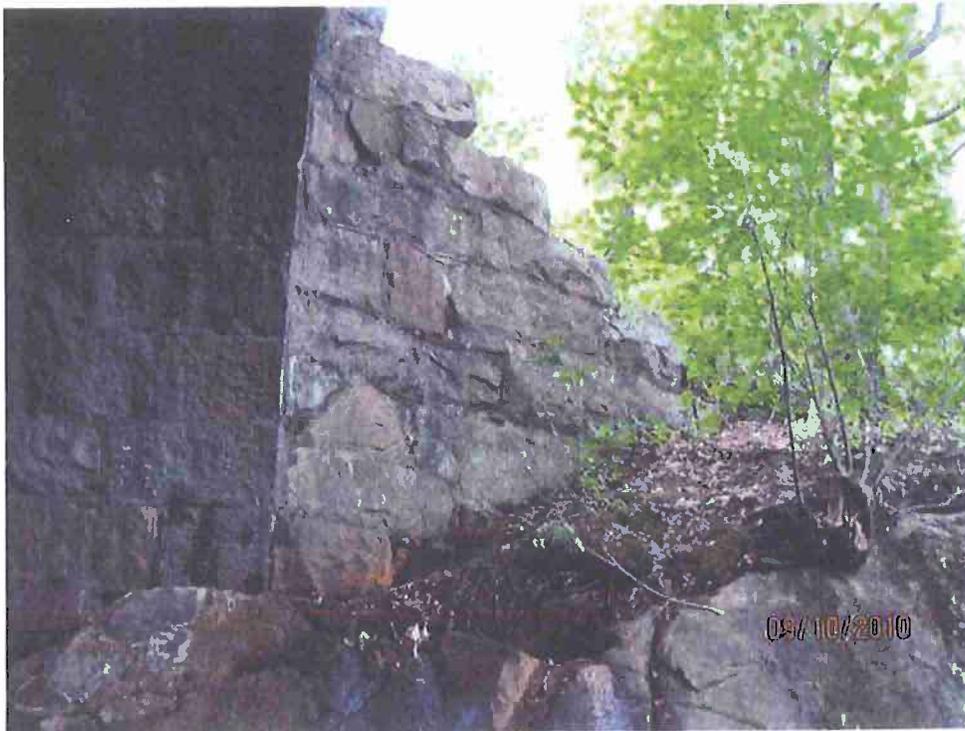
**Photo #14 - Southwest Embankment Retaining Wall**

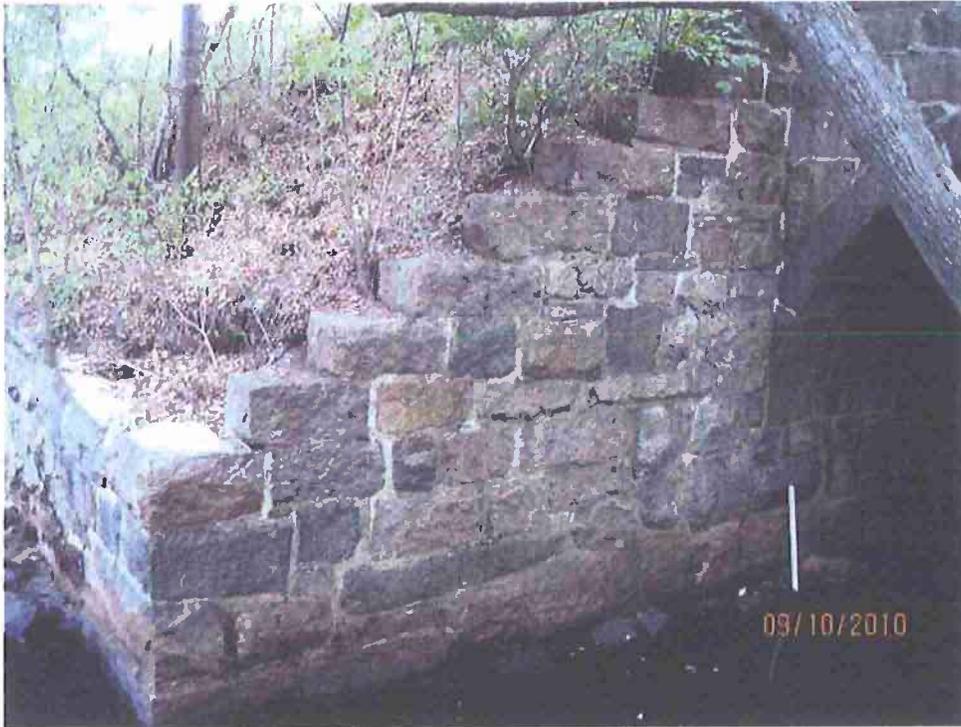
Photo #15 – Northwest Wingwall

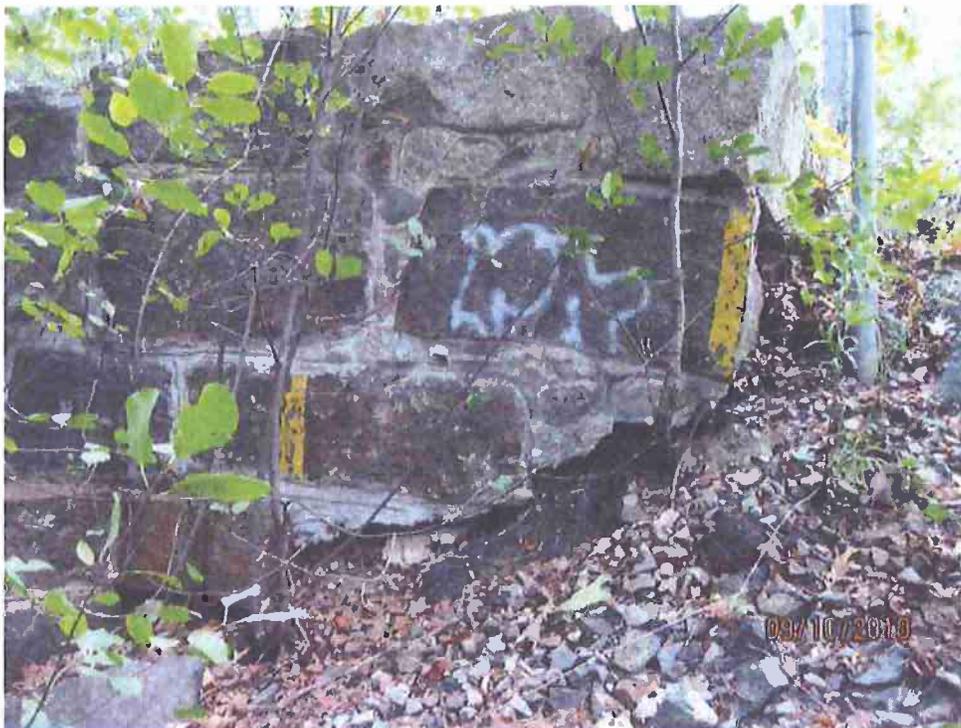
Photo #16 – Undermining at Retaining Wall at Southwest End

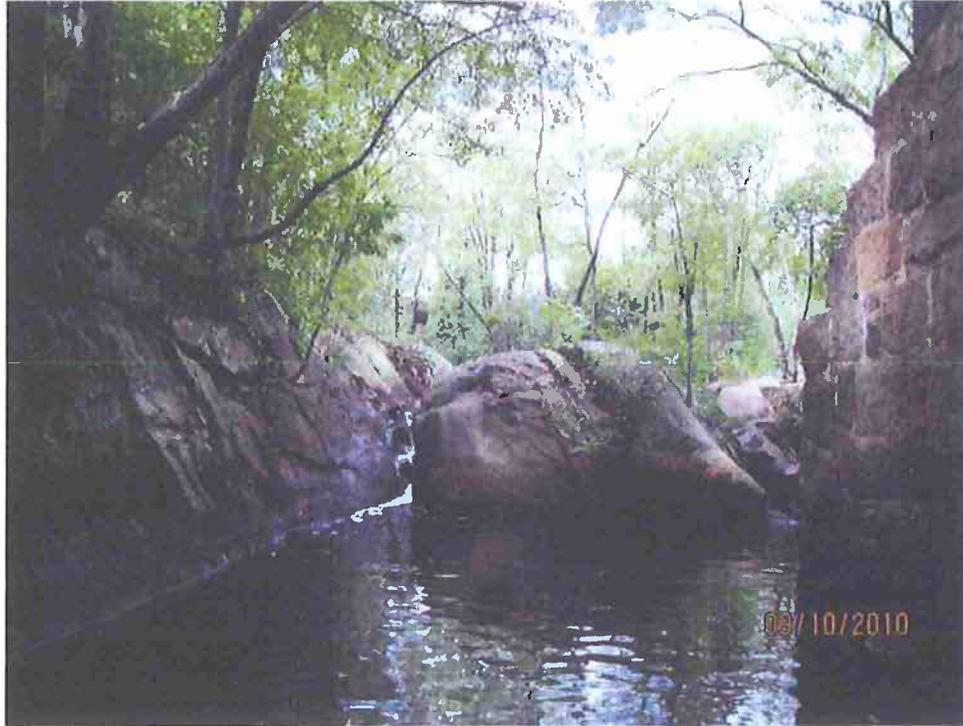
The channel was scattered with larger stones throughout the middle of the arch and moderate debris was found upstream. There is moderate local scour along the southwest inlet. A small sandbar was also found at the northeast embankment.

Photo #17 – Upstream

- Clear debris downstream.
- Continue to monitor local scour conditions.

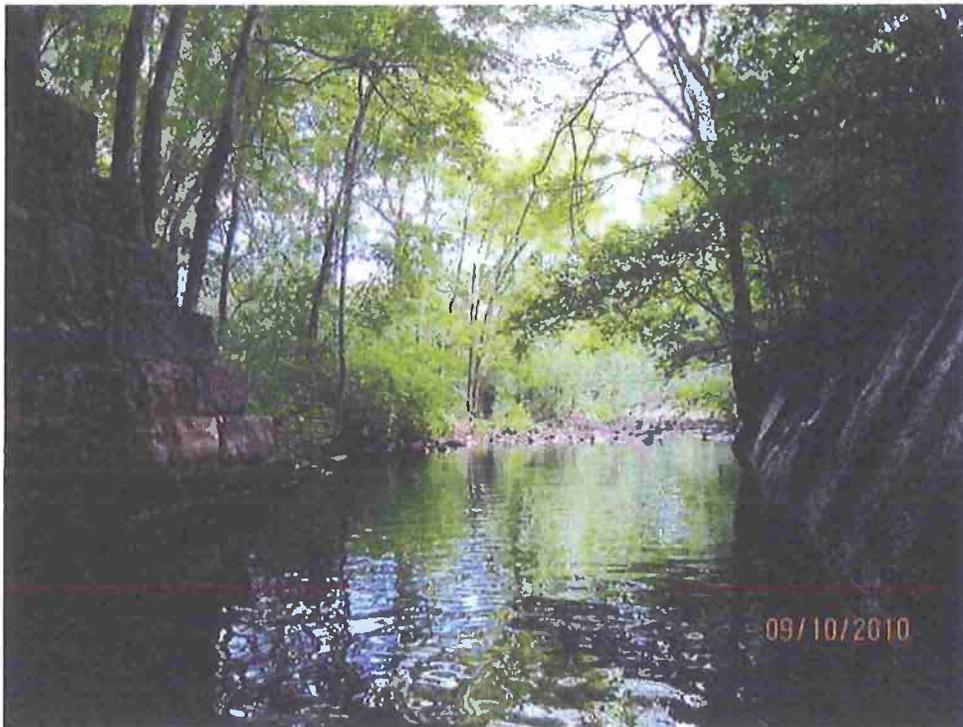
Photo #18 – Downstream

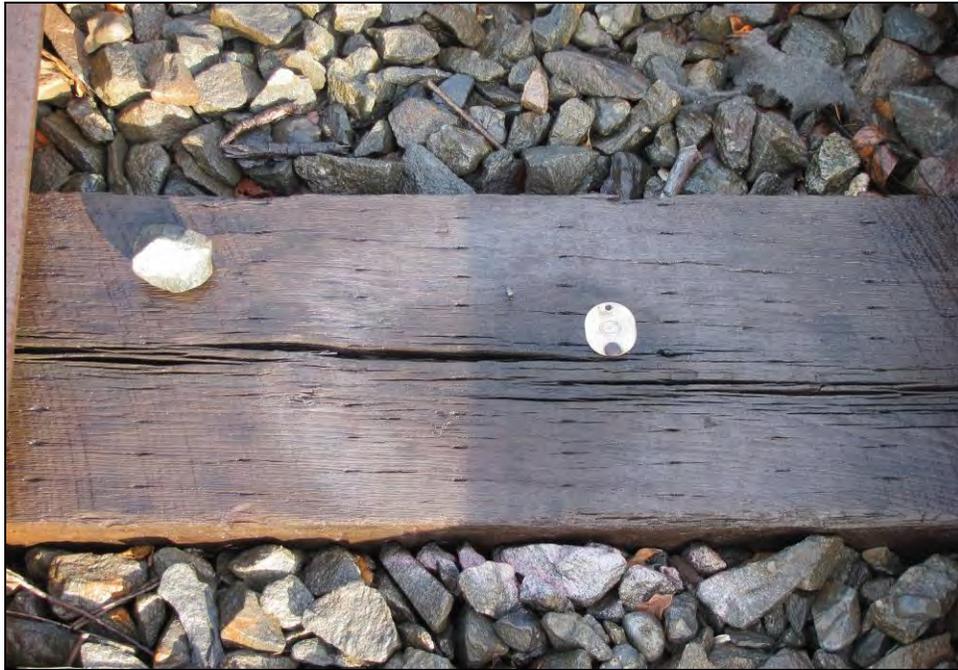
- 58.3 Ties (Good)** – Timber ties exhibit minor checking. Approach ties in both directions exhibit minor to moderate checking (**see photo 13**).
- 58.5 Walkways (Good)** – 4'-0" wide steel grate walkway on the west side of the bridge with minor vegetation growth through the steel grate at the north end (**see photo 14**).
- 58.8 Handrails (Good)** – 4'-0" high steel handrail on the west side of the bridge walkway exhibits minor scrapes and spotty light rust on top rail.
- 58.9 Utilities (Good)** – There are six 5" outside diameter utility conduits running beneath the west side of the superstructure with no deficiencies noted.
- 58.10 Approach Settlement (Good)** – No deficiencies noted.

Photo No. 13 – South approach ties with moderate checking

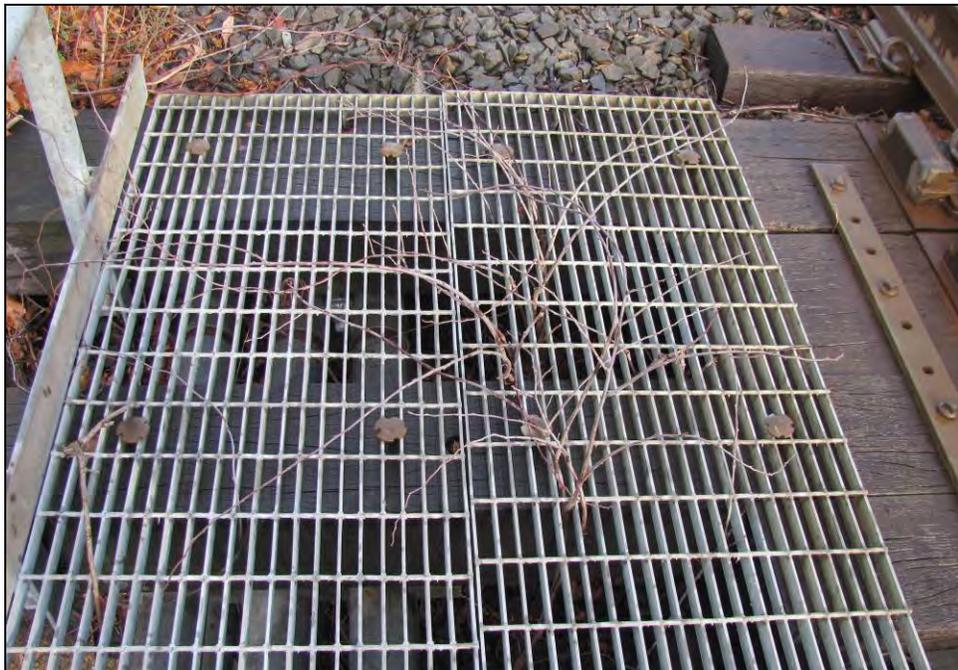
Photo No. 14 – Minor vegetation growth through steel grate walkway

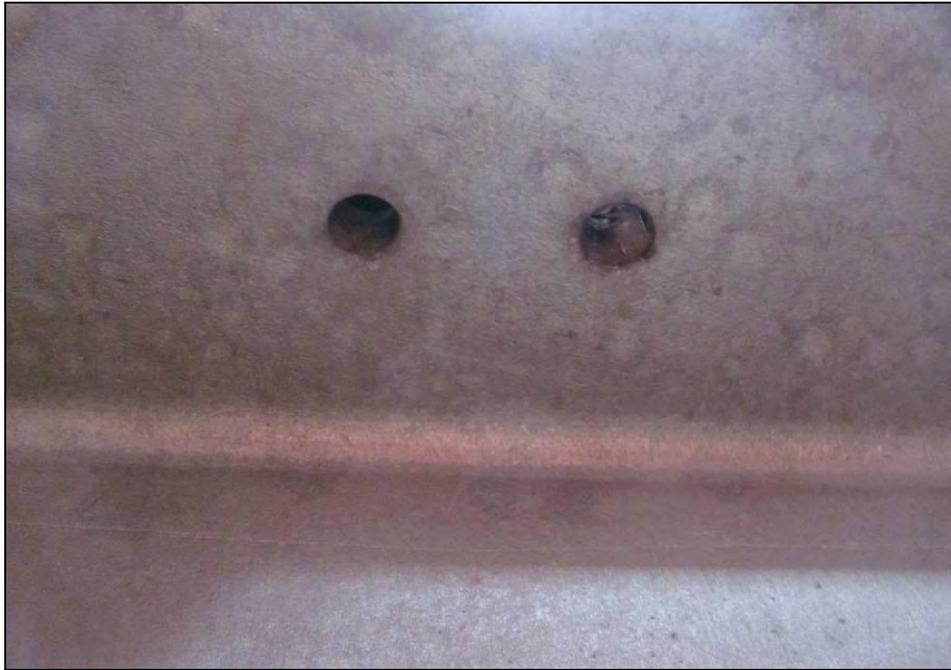
- 59.1a Top Flange (Good)** – Beams exhibit spotty light rust on top flange. There are prefabricated unused holes in the top flange at the north end of beams C and D and also at the south end of Beams A and B (**see photo 15**).
- 59.1b Bottom Flange (Good)** – Beams exhibit spotty light rust on bottom flange.
- 59.1c Web (Good)** – No deficiencies noted.
- 59.1e Bearing Stiffeners (Good)** – No deficiencies noted.
- 59.1f Diaphragms (Good)** – Diaphragms exhibit spotty light rust on the top and bottom flanges.
- 59.1j Welds (Very Good)** – No deficiencies noted.
- 59.1k Connection Plates (Good)** – No deficiencies noted.

Photo No. 15 – Unused holes in top flange at north end of Beams C and D

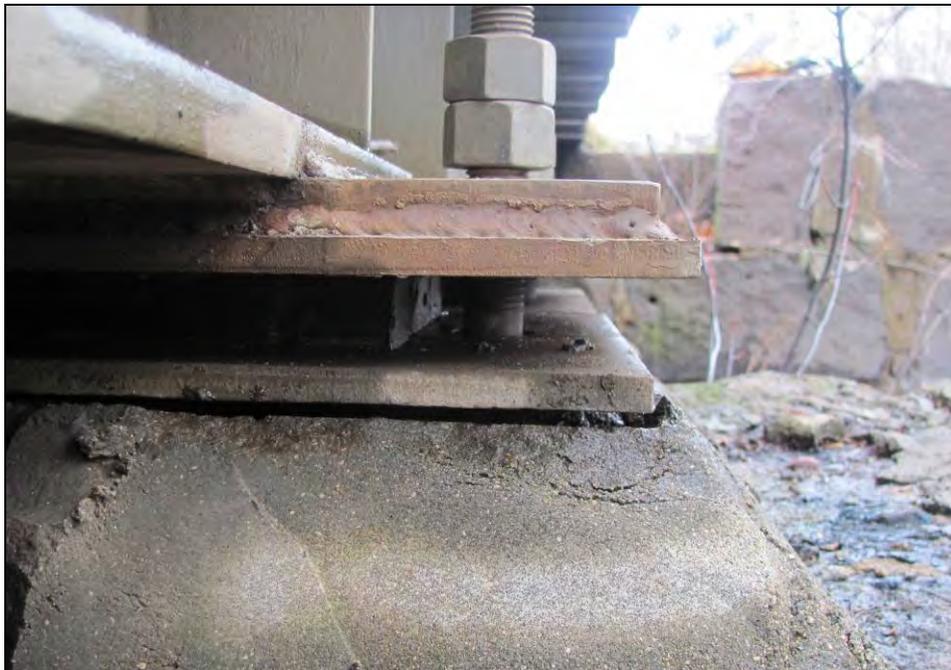
59.1q Bearings (Satisfactory) – Bearing sole plates exhibit light rust throughout. There is up to a 1” gap between the masonry plate and the grout pad on the north bearing of Beam D in Span 2 that closes completely during the passing of trains (**see photo 16**). West anchor bolts on the north bearing of Beam D in Span 1 are tilted southwest (**see photo 17**). The north bearing of Beam D in Span 2 is missing both nuts on the west anchor bolt. The second nut on anchor bolt is backed off at several bearing locations.

Photo No. 16 – Up to 1" gap between masonry plate and grout pad on Beam D north bearing at Pier 2

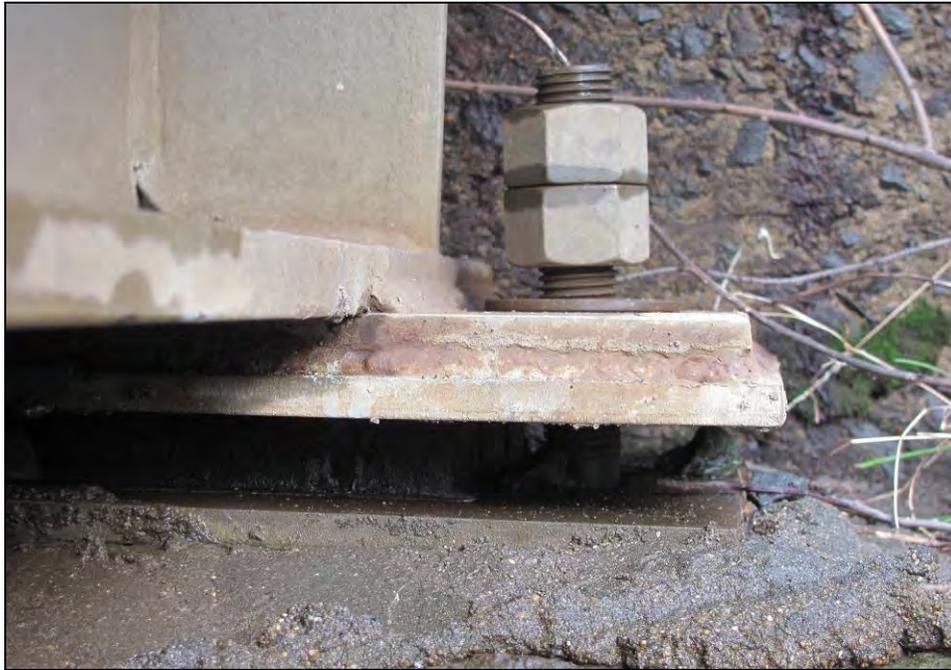
Photo No. 17 – Anchor bolt misalignment at Span 1, Beam D

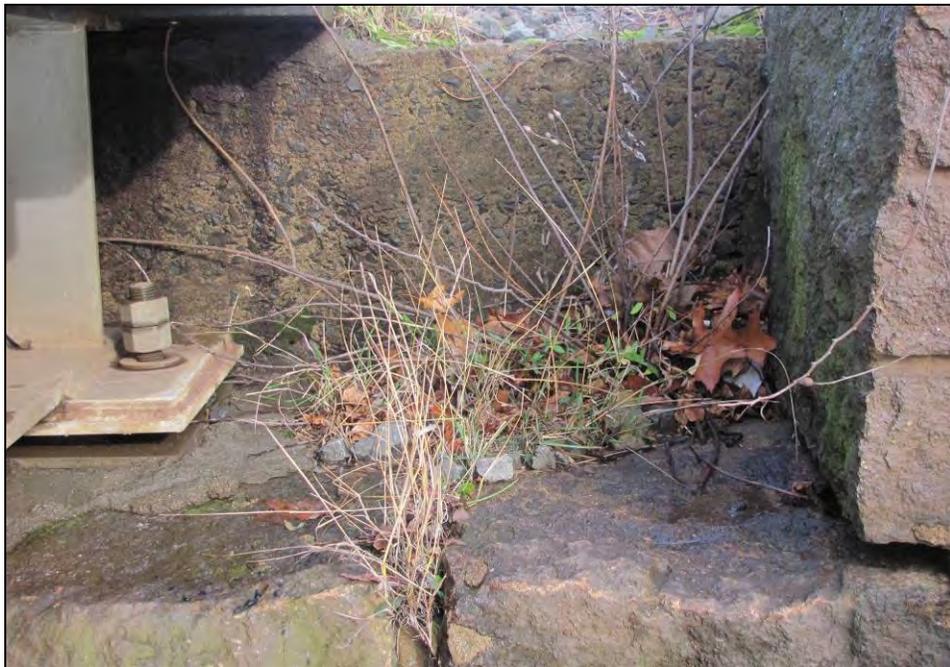
60.1e Bridge Seats (Good) – There is minor vegetation growth on all bridge seats (**see photo 20**). There is minor accumulation of debris on the South Abutment bridge seat.

Photo No. 20 – Minor vegetation growth on bridge seat (typ.)

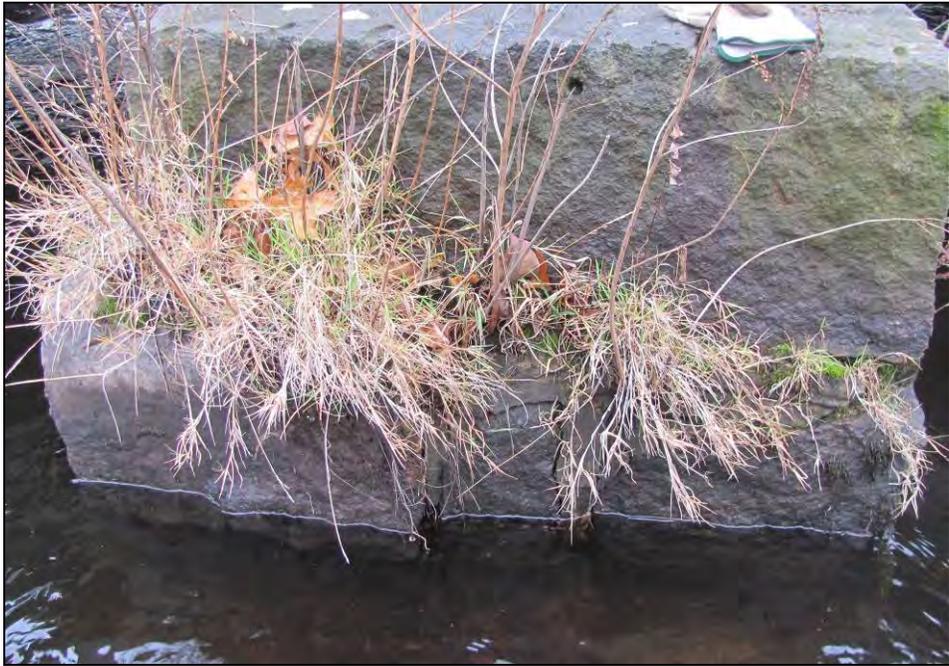
Photo No. 21 – Moderate vegetation growth between joints at east end of Pier 2

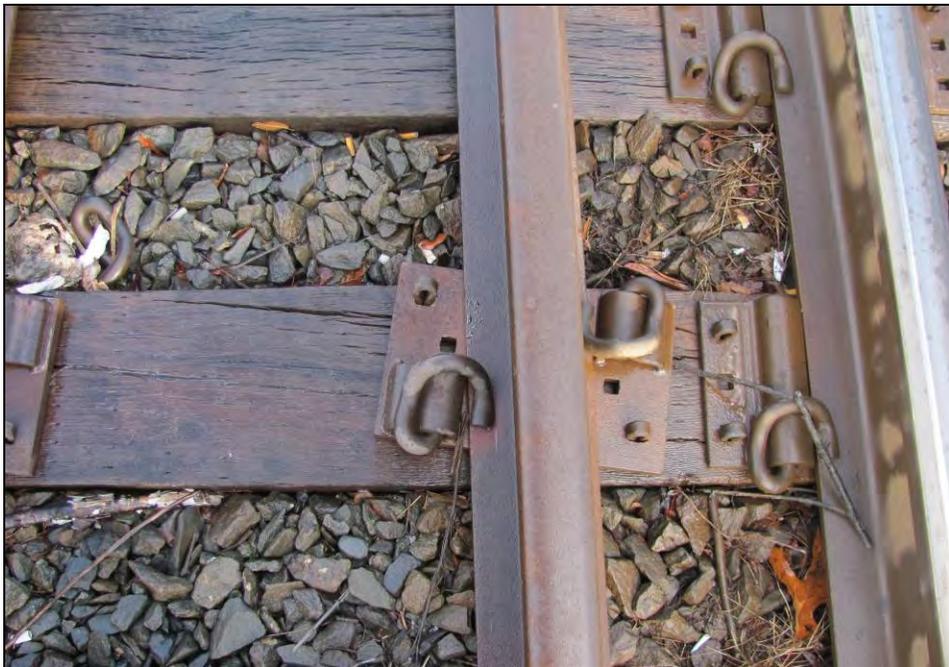
Rail Fasteners (Good) – There are several misaligned track guard rail tie plates with missing pins on the North Approach (**see photo 24**). Rail fasteners on the bridge are in good condition with no deficiencies noted.

Photo No. 24 – Misalignment of tie plate under track guard rail at the North Approach

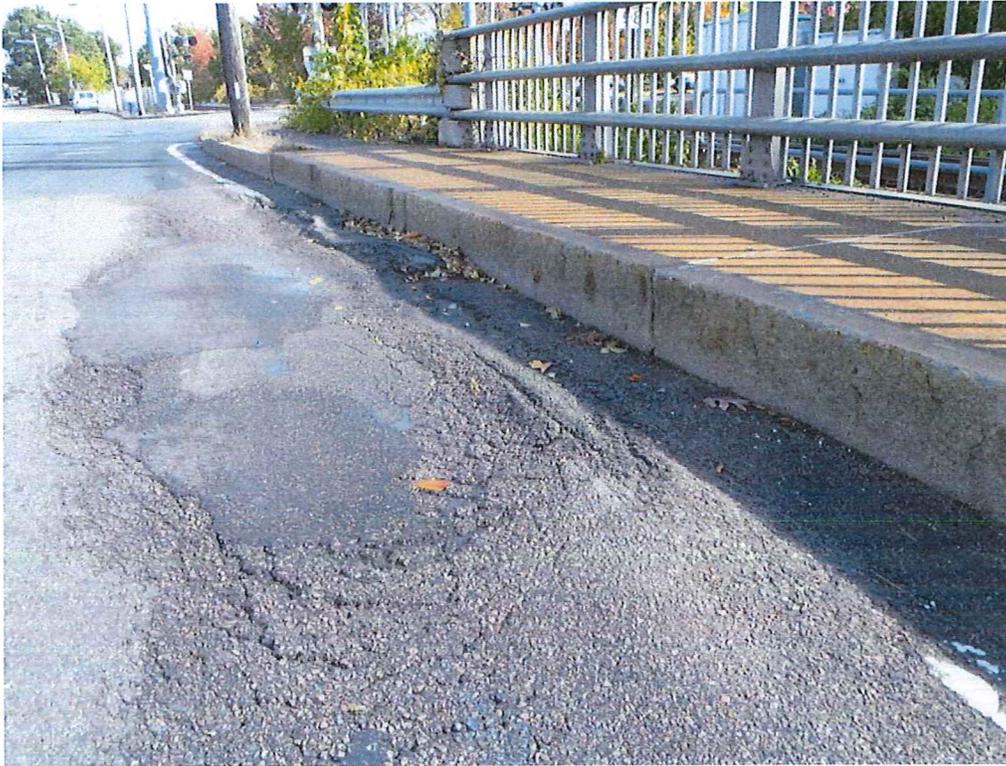
Photo 1: Bunched up bituminous in north travel lane with patches, just off of the east curb.

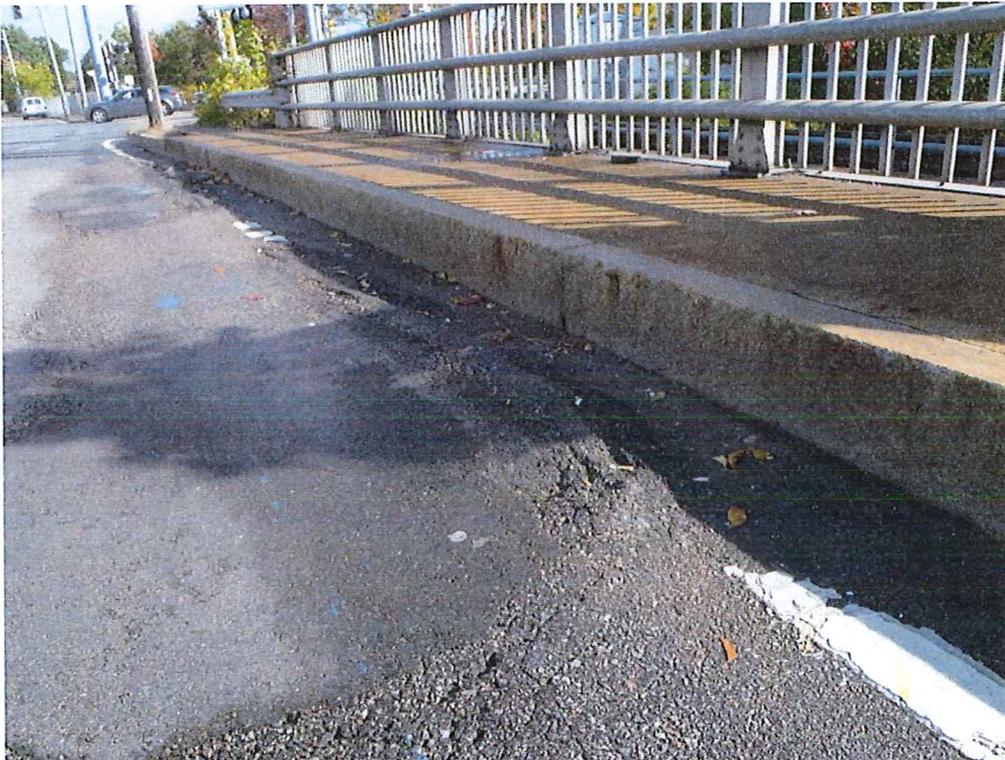
Photo 2: Northbound roadway south half 1' out at fog line along east curb, bituminous is pushing up, 12' L x 1.5' W x up to 3" H.
