APPENDIX D

Drawings and Inspection Reports of Bridges in Area

Armstrong Dam Removal Feasibility Study

BRIDGE NO. B-21-041

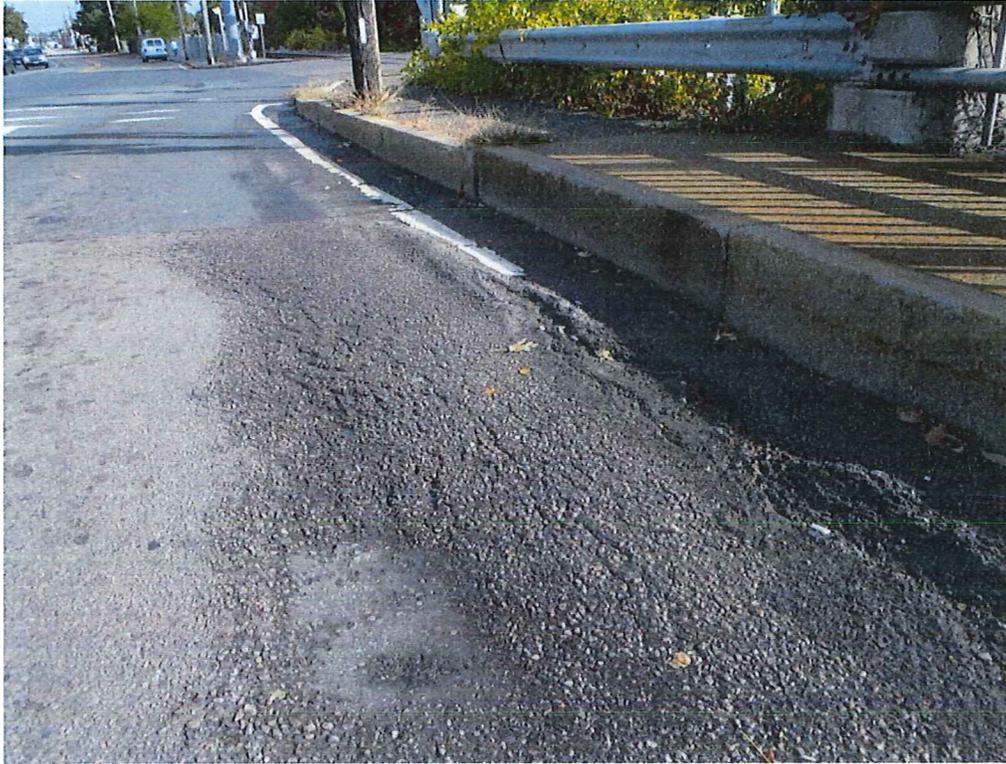
Photo 3: Northbound roadway north half just off the east curb, bituminous is pushing up for an area of 23' L x 2' W x up to 6" H.

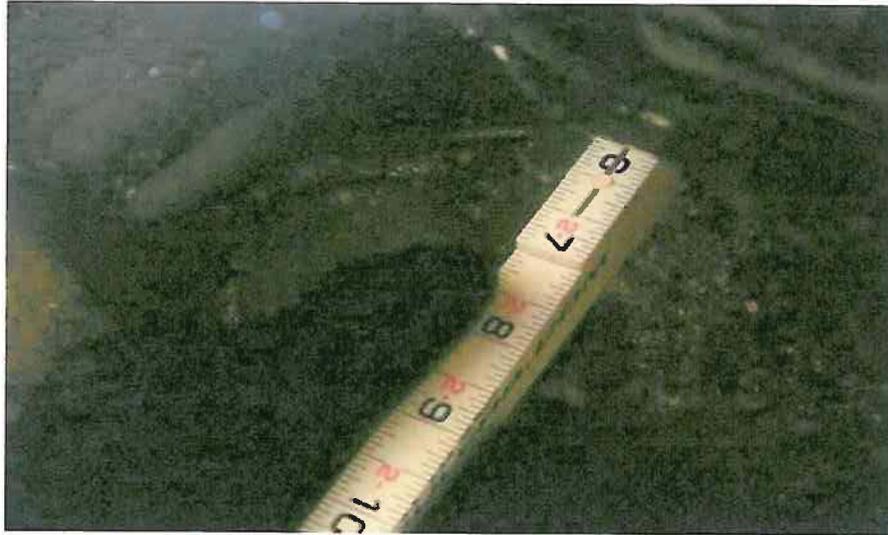
Photo 003

North east wingwall - undermining 2'+ deep

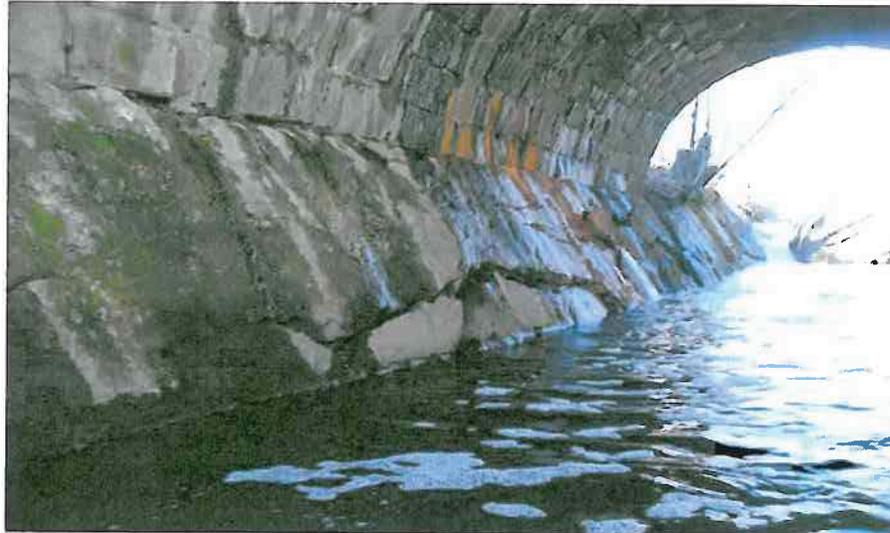
Photo 004

South Footing - 3-4" wide fractures throughout bedrock

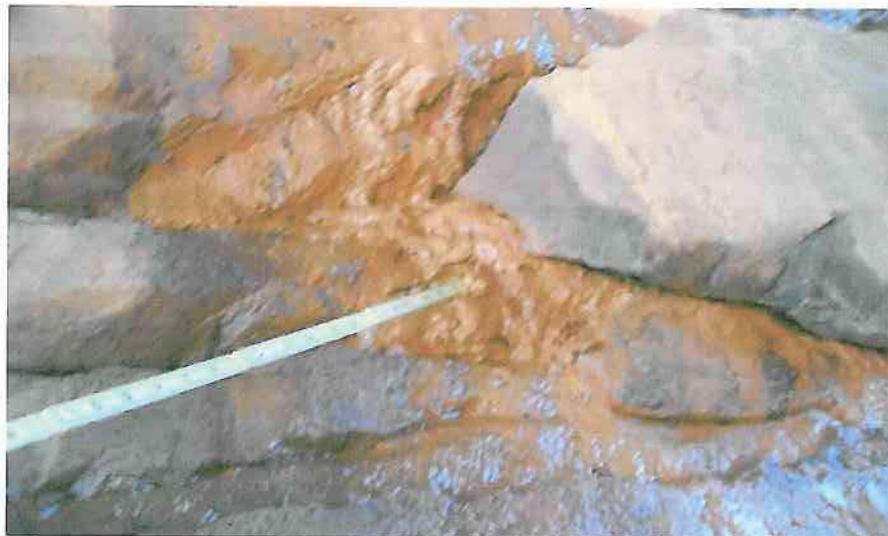
Photo 006

South Footing - iron staining (typ)

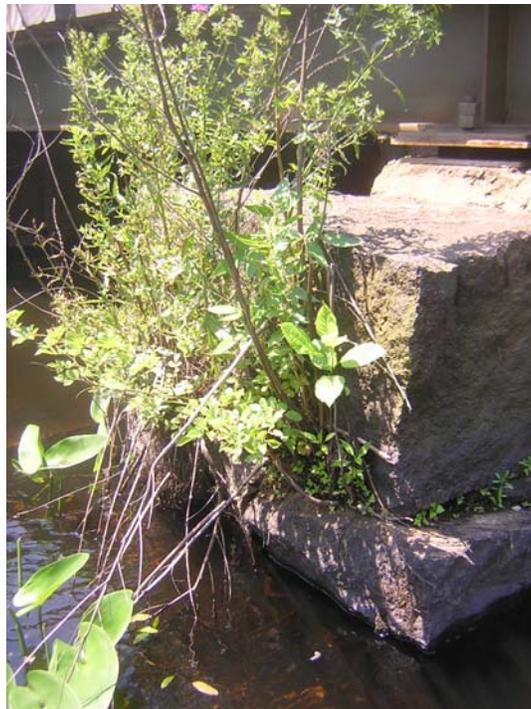
Photo 7- Pier 2, east end

The voids and the loose, missing, cracked mortar joints of the abutments, wingwalls, and piers should be repaired to prevent further deterioration. These areas can be repaired by chipping away at the deteriorated mortar, cleaning and repointing. The corrugated drain pipe should be repaired to prevent further fill material loss from behind the abutment. The pipe can be sleeved and the voids filled with a non-shrink grout. The vegetation and undergrowth on the abutments should be removed to prevent further deterioration and separation of the mortar joints. The debris pile should be removed and riprap should be placed along the pier faces to prevent further scouring along the pier faces.
